# NSPIRE for Housing Choice Voucher PowerPoints Day 3

October 2025

# NSPIRE for HCV (NSPIRE-V) Day 3

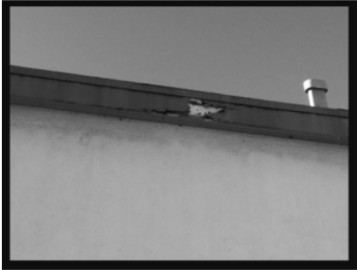
*Not a Structural System deficiency*

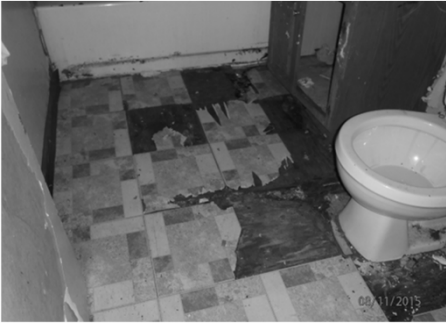
*Rotted floor, almost fell through*

Structural system exhibits signs of serious failure and may threaten the resident’s safety.
