# NSPIRE for Housing Choice Voucher PowerPoints Day 3

August 2025

**NSPIRE for HCV  
(NSPIRE-V)  
Day 3**

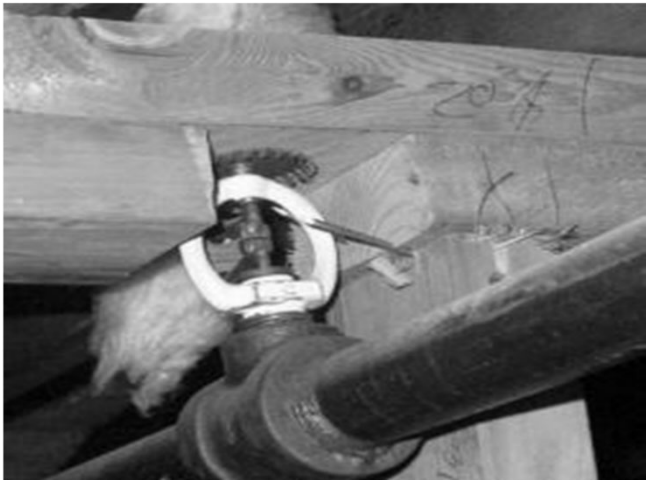
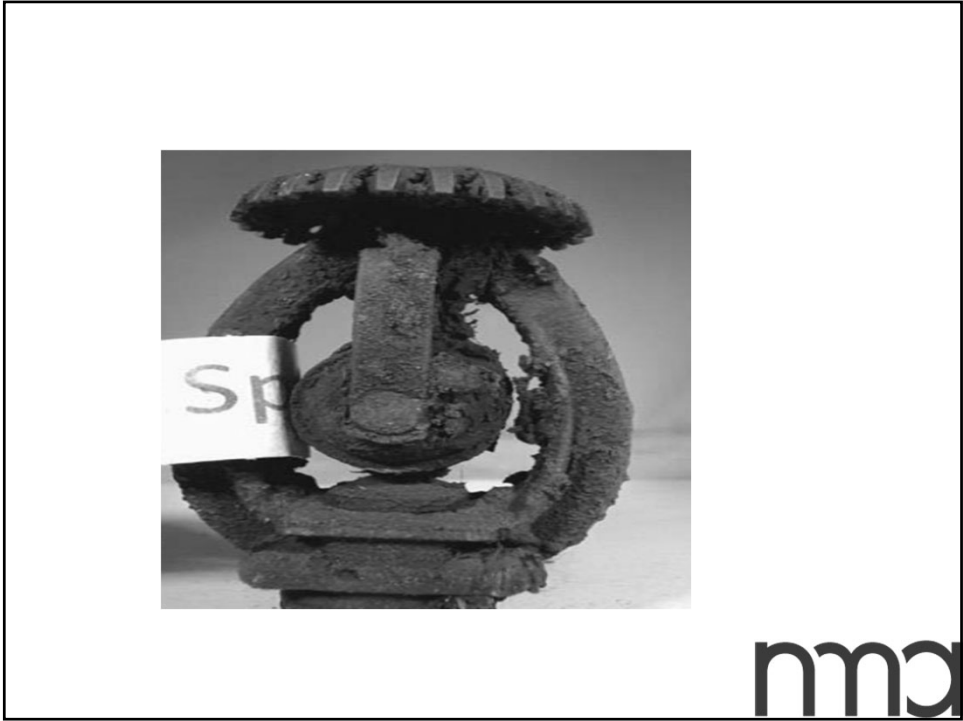
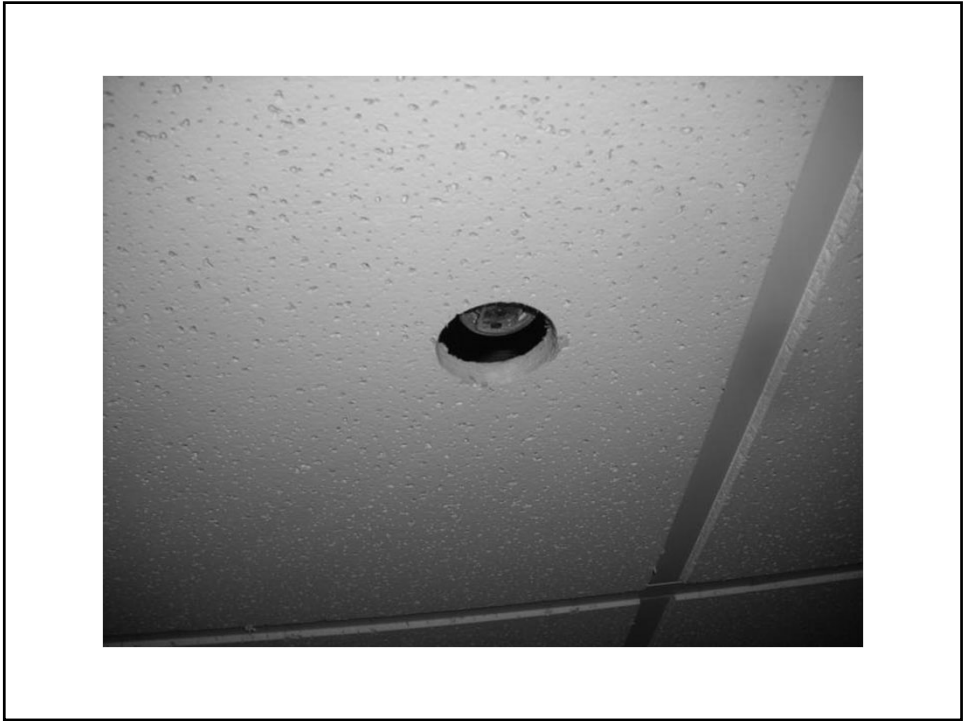
Deficiency 1: Sprinkler head assembly is encased or obstructed by an item or object that is within 18 inches of the sprinkler head.

Deficiency 2: Sprinkler assembly component is damaged, inoperable, or missing and it is detrimental to performance.	
Deficiency Criteria:	
Unit, Inside, & Outside:	Sprinkler assembly component is damaged, inoperable, or missing and it is detrimental to performance.
H&S Determination:	Correction Timeframe:
Unit, Inside, & Outside: Life-Threatening / Fail	Unit, Inside, & Outside: 24 hours
More Information:	
Unit, Inside, & Outside:	<ul style="list-style-type: none"> <li>For the purpose of this Standard, a condition is detrimental to performance if it impacts the sprinkler assembly's ability to properly or adequately discharge when activated.</li> <li>Examples of conditions that may be detrimental to performance may include, but are not limited to: <ul style="list-style-type: none"> <li>Physical damage</li> <li>Glass bulb has lost fluid</li> <li>Concealed sprinkler cover plate is caulked or glued to ceiling</li> <li>Missing sprinkler head escutcheon</li> </ul> </li> </ul>

<h2>Sprinkler Assembly</h2>	
Deficiency 3: Sprinkler assembly has evidence of corrosion.	
Deficiency Criteria:	
Unit, Inside, & Outside:	Sprinkler assembly has evidence of corrosion.
H&S Determination:	Correction Timeframe:
Unit, Inside, & Outside: Life-Threatening / Fail	Unit, Inside, & Outside: 24 hours
More Information:	
Unit, Inside, & Outside:	<ul style="list-style-type: none"> <li>None</li> </ul>

Deficiency 4: Sprinkler assembly has evidence of foreign material that is detrimental to performance.			
Deficiency Criteria:			
Unit, Inside, & Outside:	Foreign material covers 75% or more of the sprinkler assembly. OR Foreign material covers 75% or more of the glass bulb.		
H&S Determination:		Correction Timeframe:	
Unit, Inside, & Outside:	Life-Threatening / Fail	Unit, Inside, & Outside:	24 hours
More Information:			
Unit, Inside, & Outside:	<ul style="list-style-type: none"><li>For the purpose of this Standard, a condition is detrimental to performance if it impacts the sprinkler assembly's ability to properly or adequately discharge when activated.</li><li>Examples of foreign material that may be detrimental to performance may include, but are not limited to:<ul style="list-style-type: none"><li>Loading / dust</li><li>Paint</li></ul></li></ul>

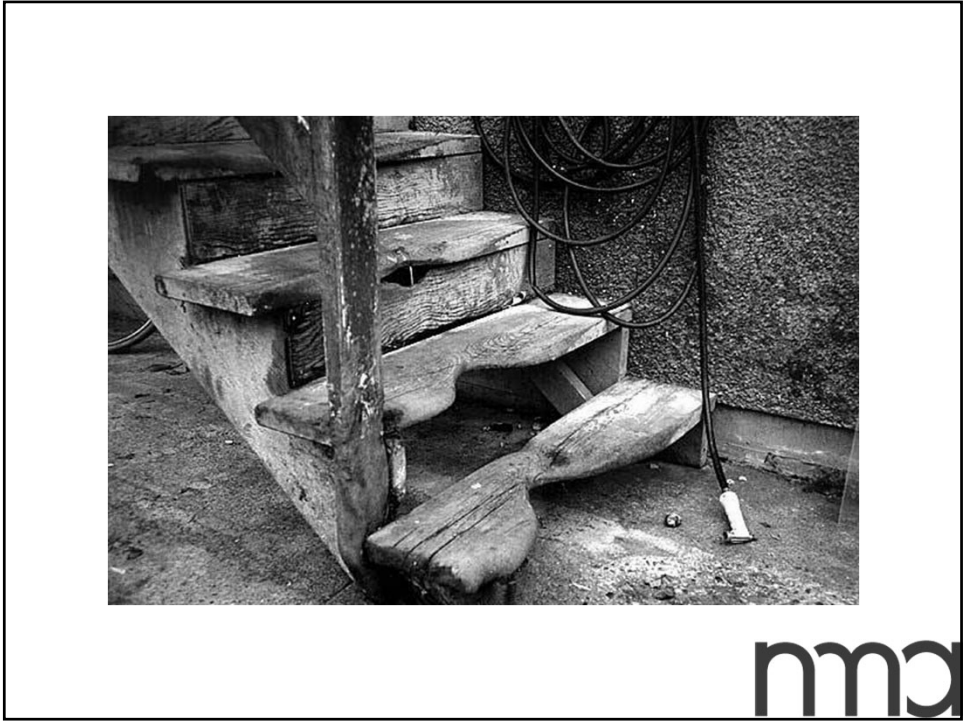
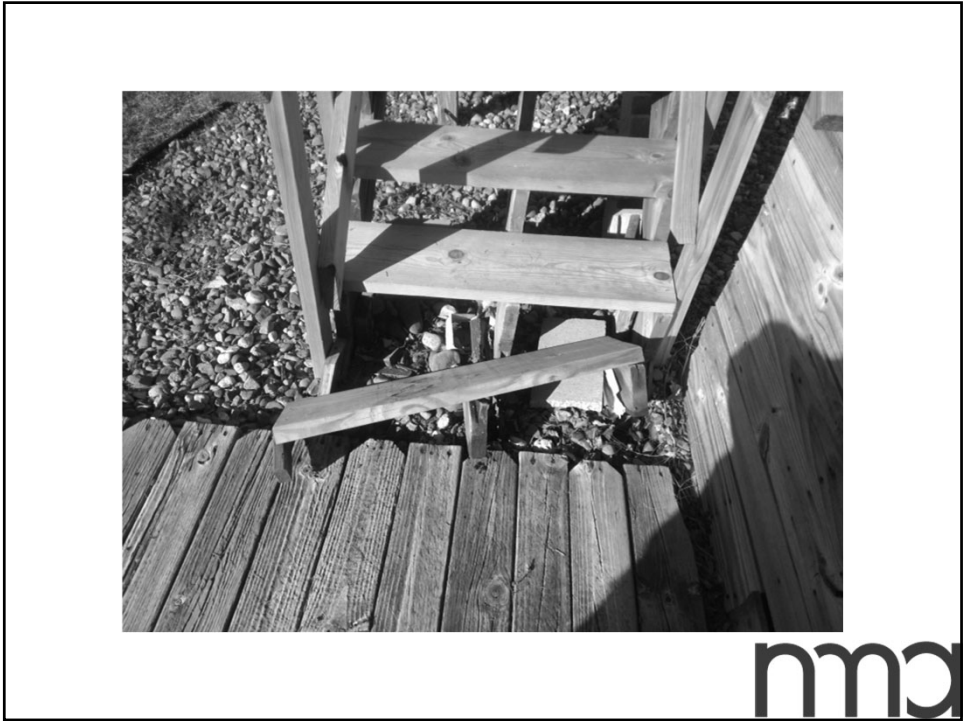
Deficiency 1: Tread is missing or damaged.	
Deficiency Criteria:	
Unit, Inside, & Outside:	Tread on a set of stairs is missing (i.e., evidence of prior installation, but now not present or is incomplete). OR Tread on a set of stairs is loose or unlevel. OR A portion of the tread nosing that is greater than 1 inch in depth or 4 inches wide is damaged or broken.
H&S Determination:	Correction Timeframe:
Unit, Inside, & Outside:	Moderate / Fail
	Unit, Inside, & Outside: 30 days
More Information:	
Unit, Inside, & Outside:	• If accessory treads are present, then verify if they are secure and level.

Unit, Inside, & Outside: Stringer is damaged (i.e., visibly defective; impacts functionality).

Deficiency 3: Step or stair is not functionally adequate.

- Conditions that may impact the functional adequacy of a step or stairs may include, but are not limited to:
  - Damage or deterioration to the extent that it disrupts a person's ability to move from one level to the next
  - Unintentional dimensional changes that may interrupt a person's walking pattern or movement
  - Unstable material

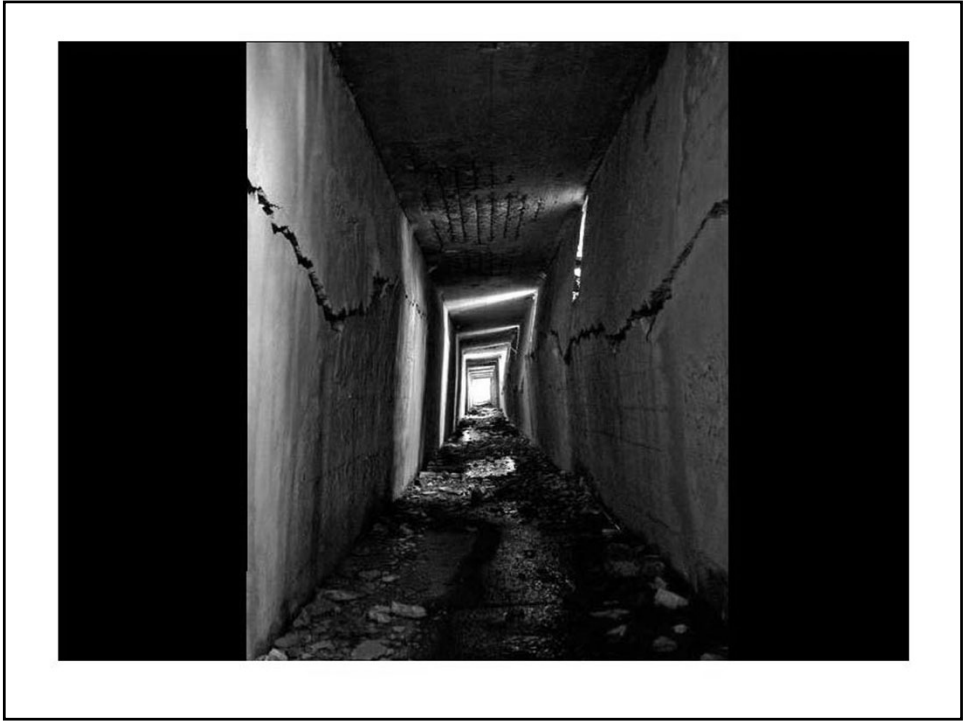
Deficiency 1: Structural system exhibits signs of serious failure.

Structural system exhibits signs of serious failure and may threaten the resident’s safety.

- If signs of failure are present and cannot be attributed to a specific structural element, then evaluate under this standard.
- If failure is present at a structural element, then it should be evaluated under the respective standard.

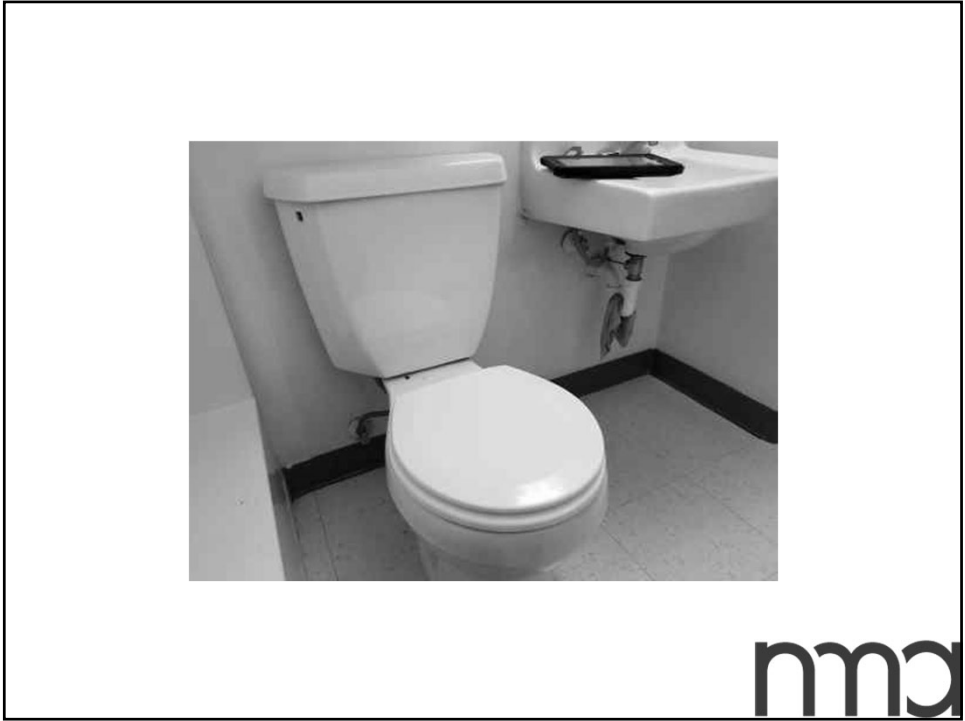
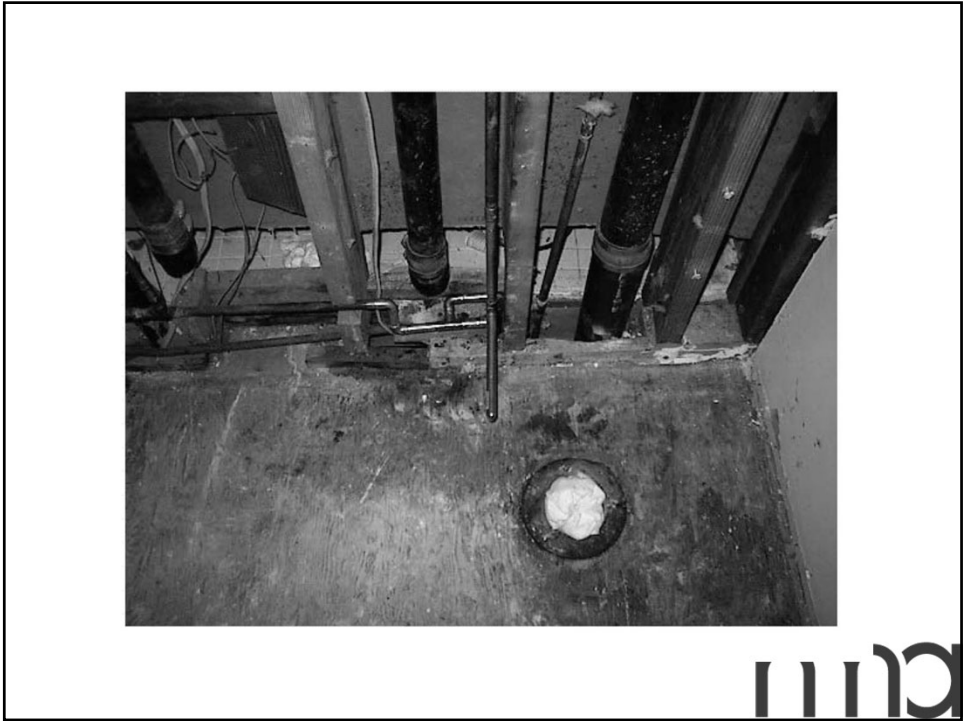
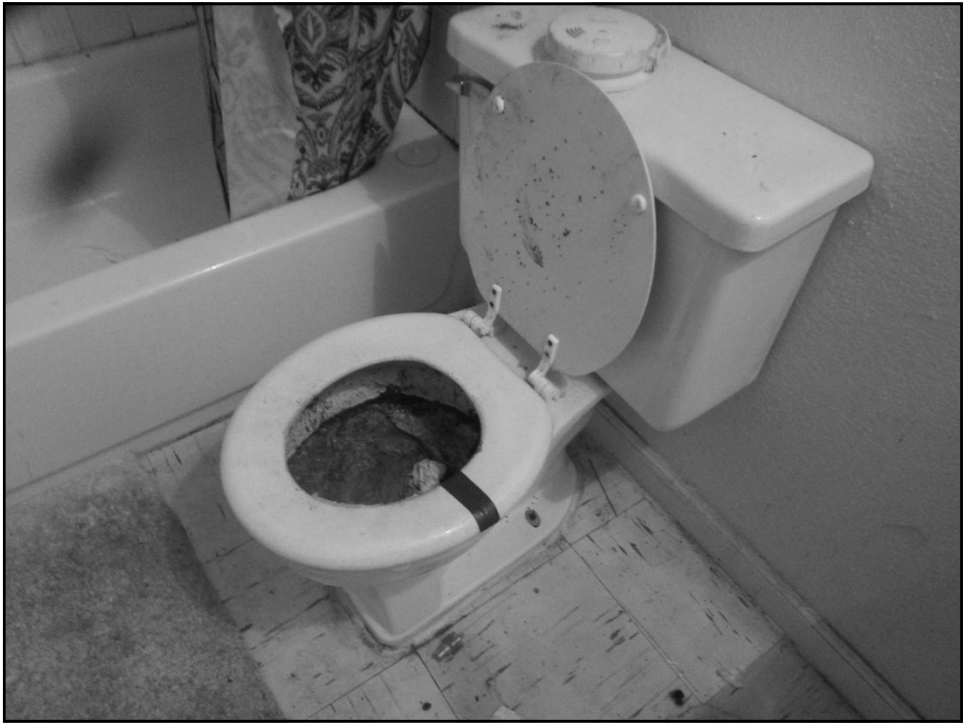
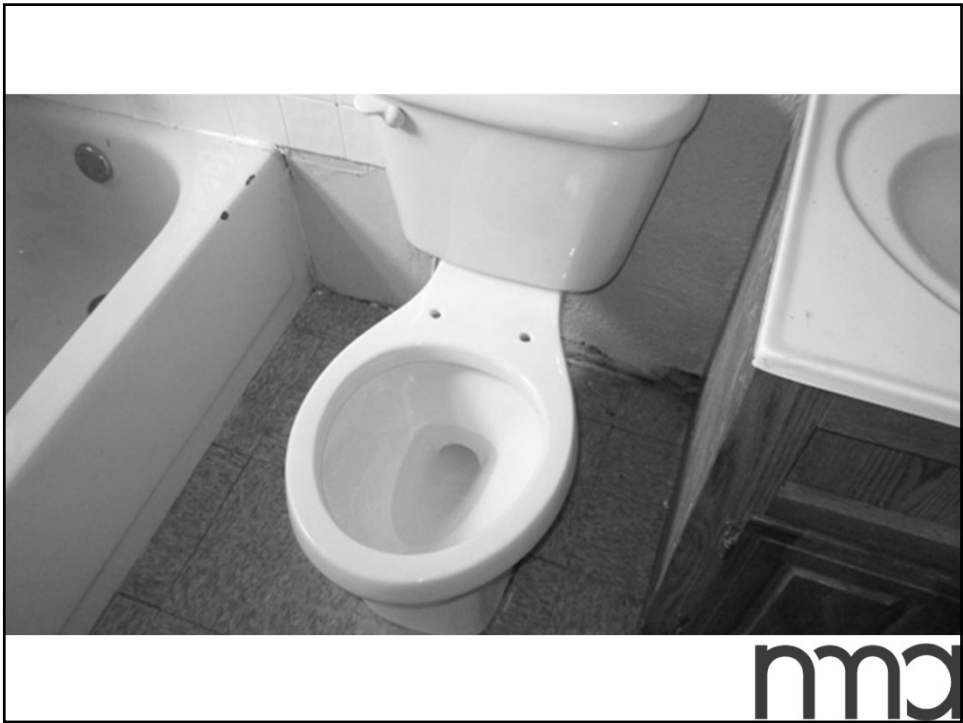
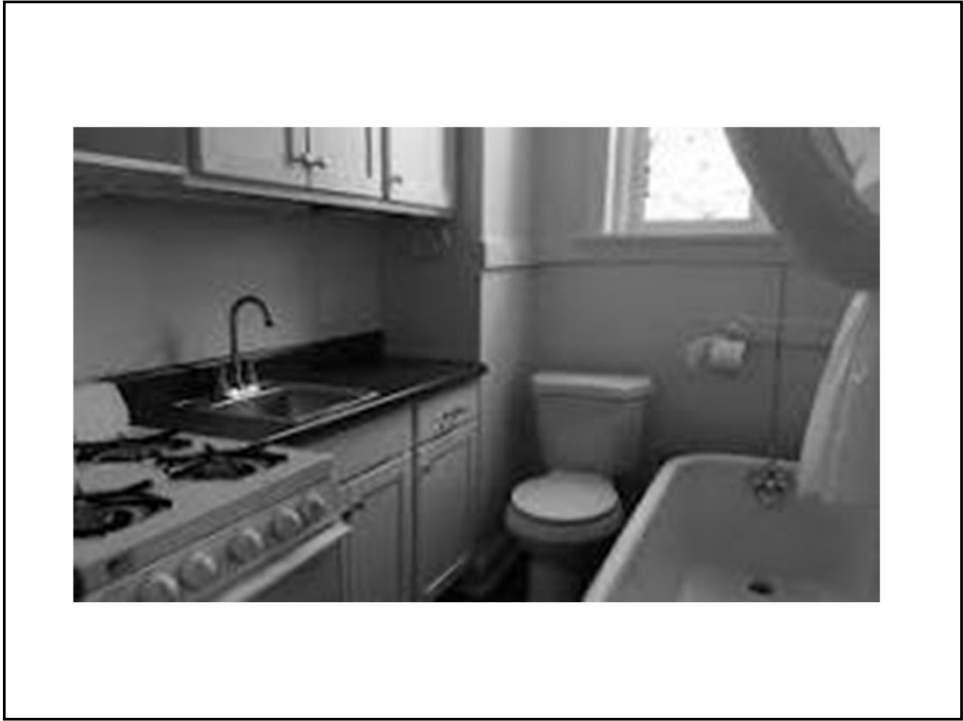
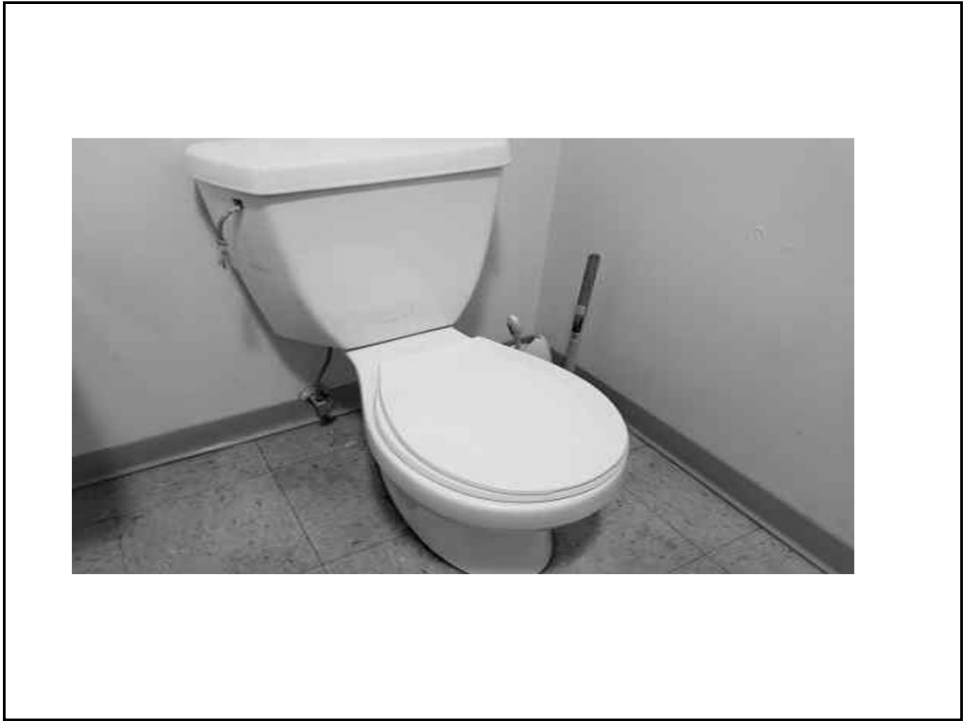
**Deficiency 1:** Only 1 toilet was installed, and it is missing.

Deficiency 3: Only 1 toilet was installed, and it is damaged or inoperable.			
Deficiency Criteria:			
Unit & Inside:	Only 1 toilet was installed, and it is damaged (i.e., visibly defective; impacts functionality). OR Only 1 toilet was installed, and it is inoperable (i.e., overall system is not meeting function or purpose; with or without visible damage).		
H&S Determination:		Correction Timeframe:	
Unit:	Severe / Fail	Unit:	30 Days
Inside:	Moderate / Fail	Inside:	30 days
More Information:			
Unit & Inside:	• If the toilet refills and continues running, then evaluate the condition under Deficiency 7 of this standard.

Deficiency 5: Toilet component is damaged, inoperable, or missing such that it may limit the resident’s ability to safely discharge human waste.

Deficiency 6: Toilet is not secured at the base.

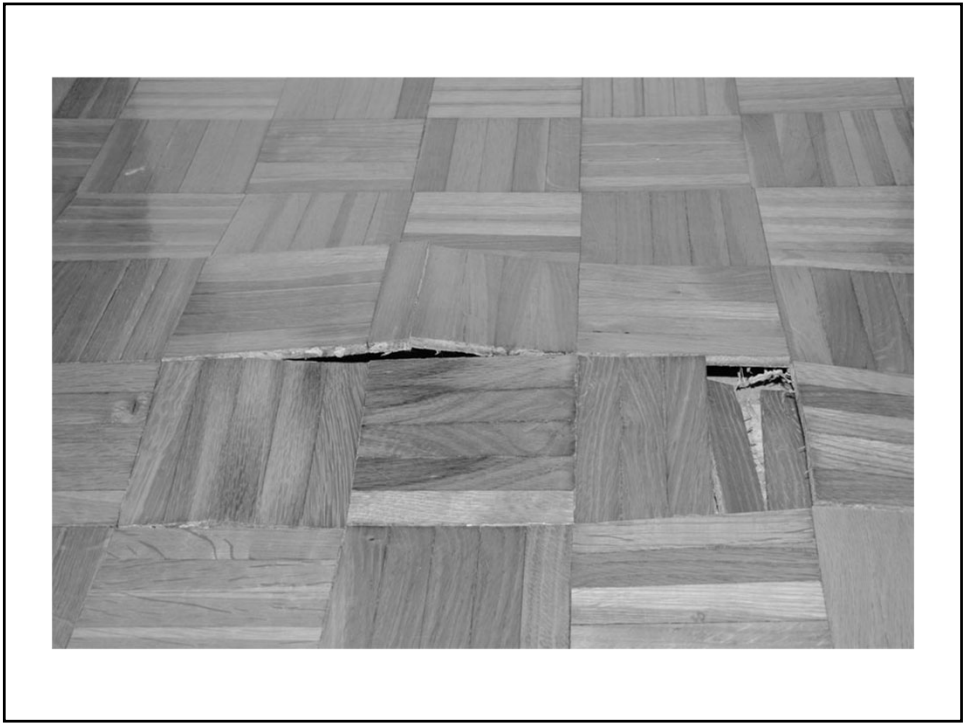
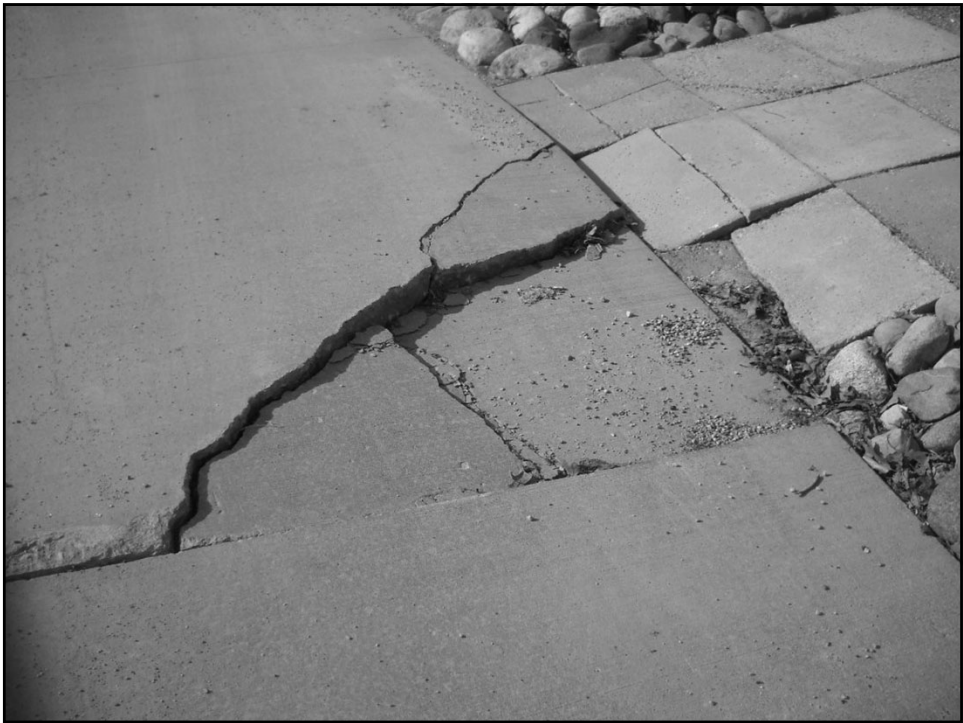
Definition:	Hazard caused by an abrupt change in vertical elevation or horizontal separation on any walking surface.
Common Components:	None
More Information:	None

Unit, Inside, & Outside:	<ul style="list-style-type: none"><li>• Examples of conditions that should not be evaluated under this deficiency include, but are not limited to:<ul style="list-style-type: none"><li>• An engineer-designed gap or vertical difference (e.g., a raised manhole or a plant grate designed in the middle of a path of travel).</li><li>• An intentional transition from a walking surface to a doorway or entrance.</li></ul></li></ul>
--------------------------------	--

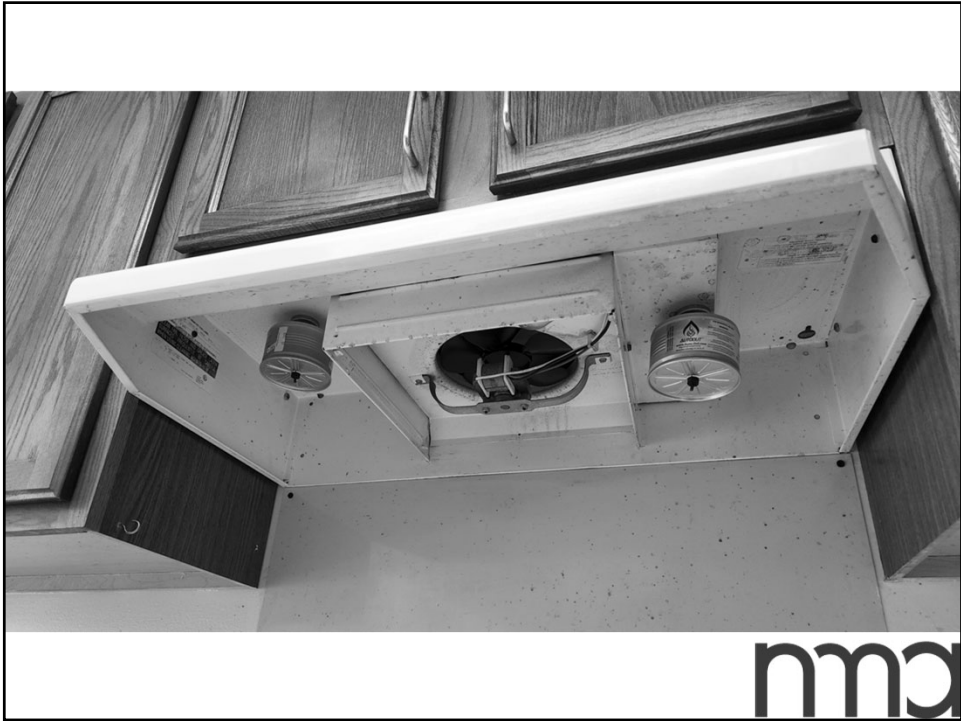
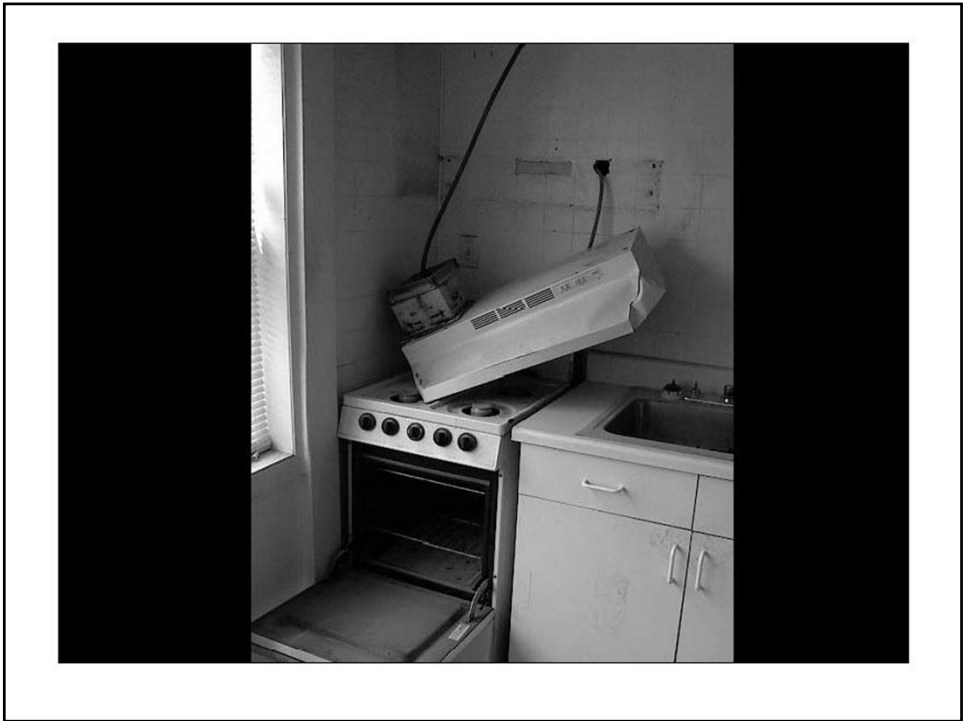
Unit & Inside:	<ul style="list-style-type: none"><li>Examples of damaged or missing components may include, but are not limited to:<ul style="list-style-type: none"><li>Fan</li><li>Filter</li><li>Screen</li><li>Duct</li></ul></li></ul>
----------------	--

Deficiency 4: Bathroom does not have proper ventilation or dehumidification.	
Deficiency Criteria:	
Unit & Inside:	Neither an exhaust fan, window, nor adequate means of ventilation or dehumidification is present and operable.
H&S Determination:	
Unit & Inside:	Moderate / Fail
Correction Timeframe:	
Unit & Inside:	30 days
More Information:	
Unit & Inside:	<ul style="list-style-type: none"><li>• A high-rise building may have a passive or motorized central ventilation system and if there is a vent in the bathroom, this may require an alternate means of detecting airflow if otherwise undetectable.</li><li>• The POA is allowed to plug in an exhaust fan if it is present and unplugged.</li><li>• Only one means of ventilation or dehumidification is required per bathroom.</li></ul>

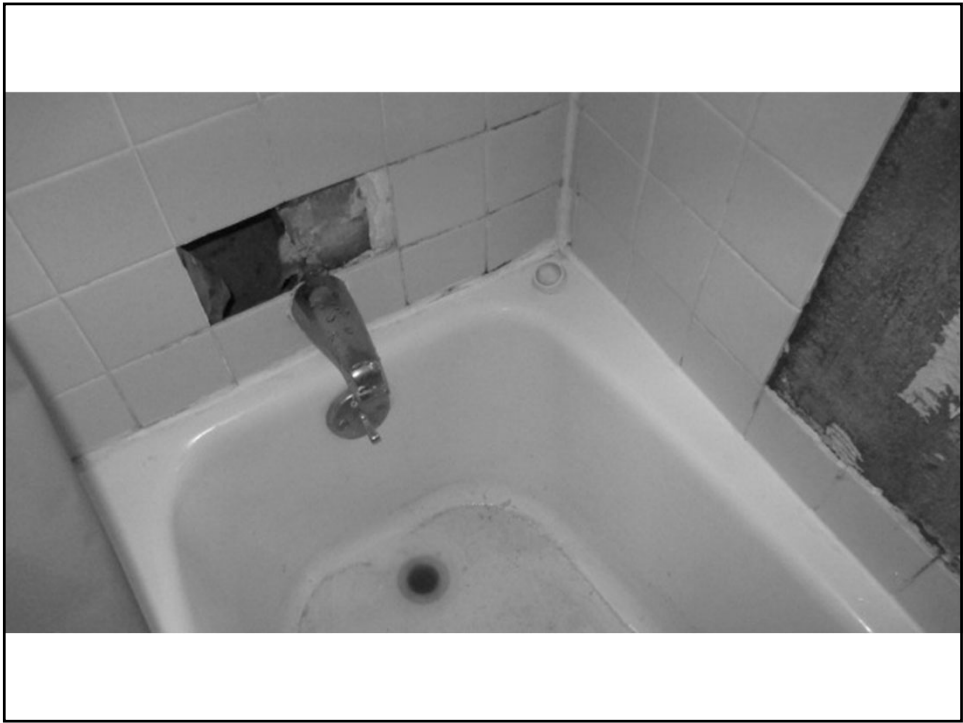
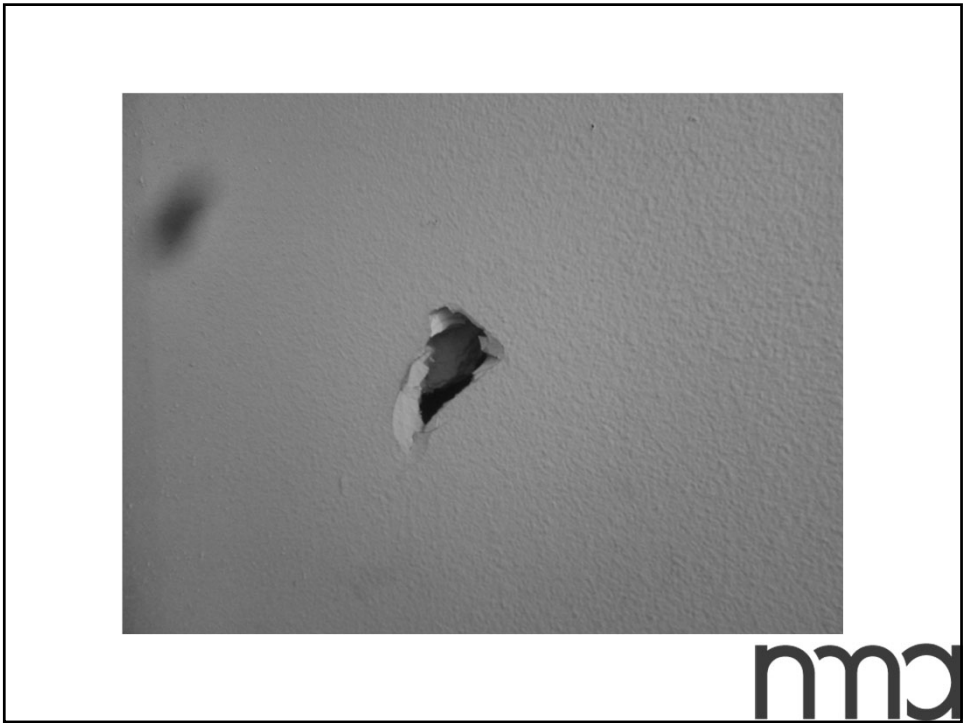
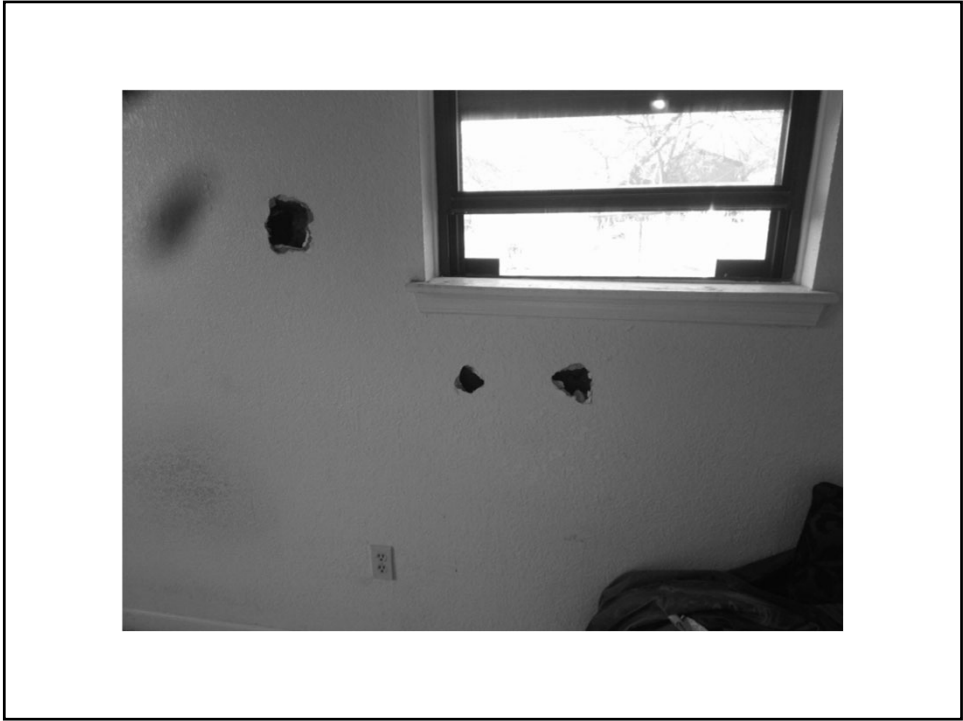
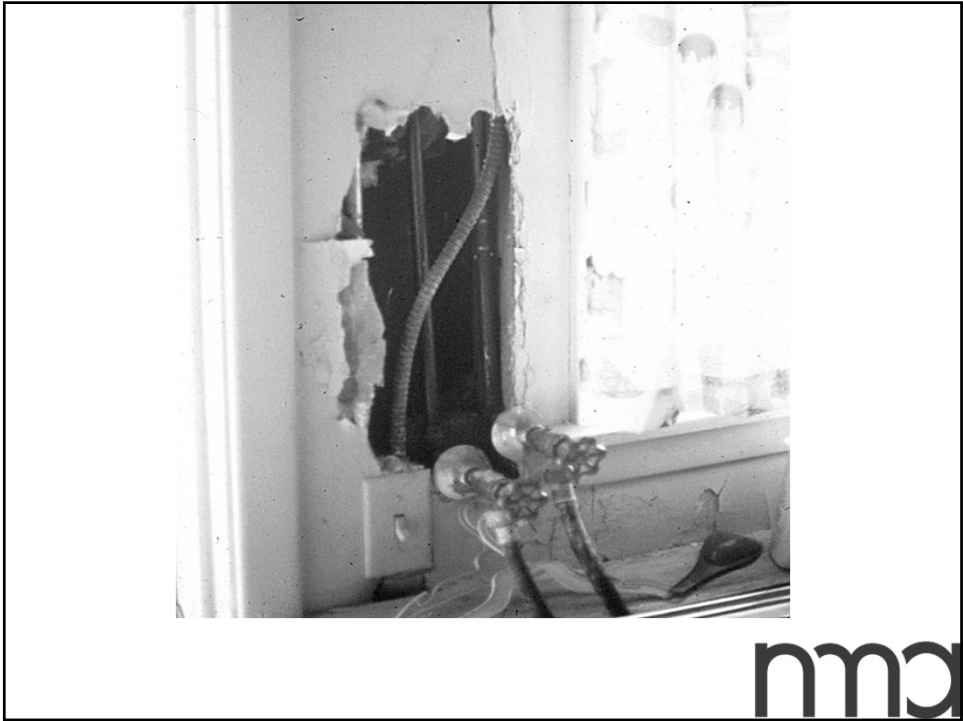
Deficiency 2: Interior wall component(s) is not functionally adequate.			
Deficiency Criteria:			
Unit & Inside:	Interior wall component(s) is not functionally adequate (i.e., impacts the integrity of the interior wall or does not allow interior wall to provide vertical separation between rooms or spaces).		
H&S Determination:		Correction Timeframe:	
Unit & Inside:	Moderate / Fail	Unit & Inside:	30 days
More Information:			
Unit & Inside:	<ul style="list-style-type: none"><li>If the overall interior wall exhibits a sign of serious failure that may threaten the resident's safety, then evaluate the condition under the Structural System standard.</li></ul>

Deficiency 3: Interior wall has a hole that is greater than 2 inches in diameter or there is an accumulation of holes that are cumulatively greater than 6 inches by 6 inches.			
Deficiency Criteria:			
Unit & Inside:	A hole is greater than 2 inches in diameter. OR An accumulation of holes in any one wall that are cumulatively greater than 6 inches by 6 inches.		
H&S Determination:		Correction Timeframe:	
Unit & Inside:	Moderate / Fail	Unit & Inside:	30 days
More Information:			
Unit & Inside:	<ul style="list-style-type: none"><li>None</li></ul>
