# NSPIRE for Housing Choice Voucher PowerPoints Day 1

**NSPIRE for HCV  
(NSPIRE-V)  
Day 1**

**Chapter 1  
Introduction**

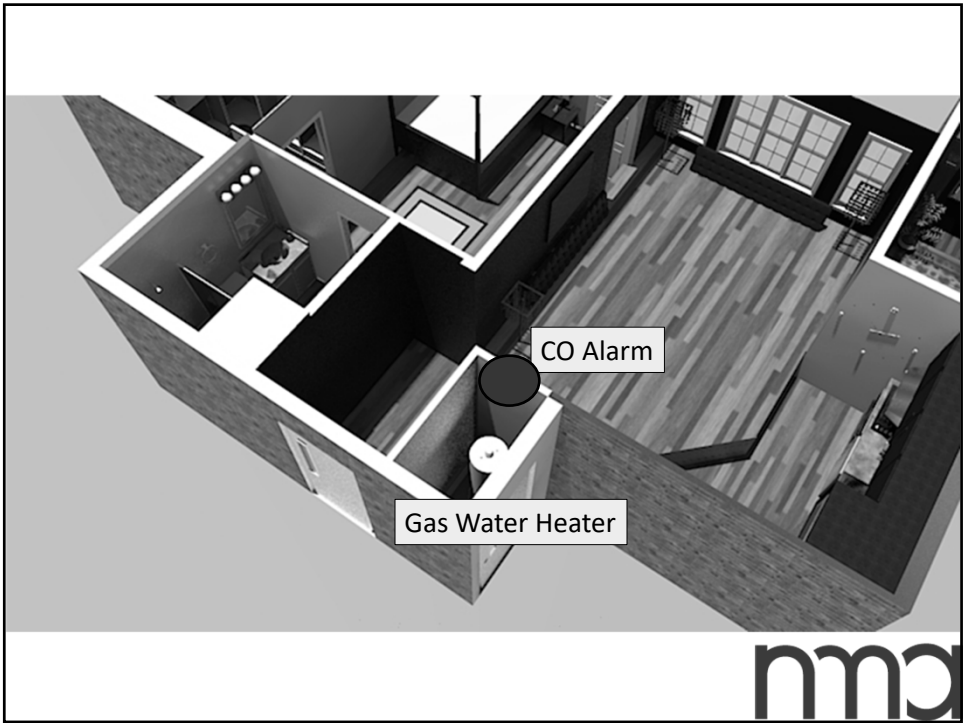
**Deficiency 1:** Carbon monoxide alarm is missing, not installed, or not installed in a proper location.

| Unit*: | One (1) or more of the following scenarios exists:<br>1. Unit contains a fuel-burning appliance or fuel-burning fireplace, and a carbon monoxide alarm is not installed:<br>a. in the immediate vicinity of each bedroom.<br><u>OR</u><br>b. within each bedroom. |

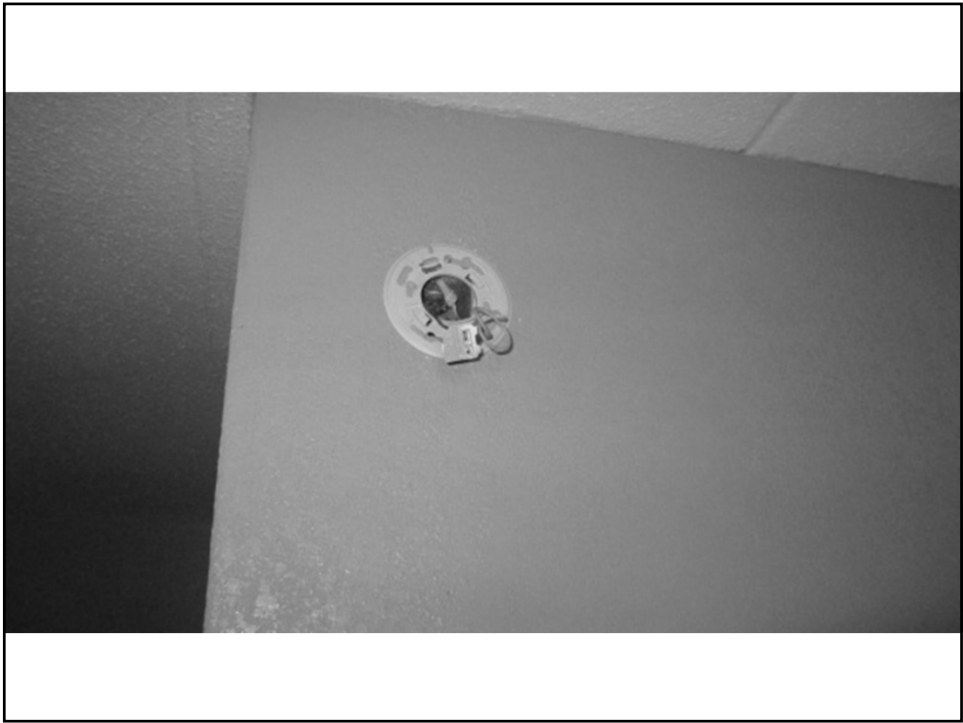
Carbon Monoxide Alarm

Deficiency 2: Carbon monoxide alarm is obstructed.

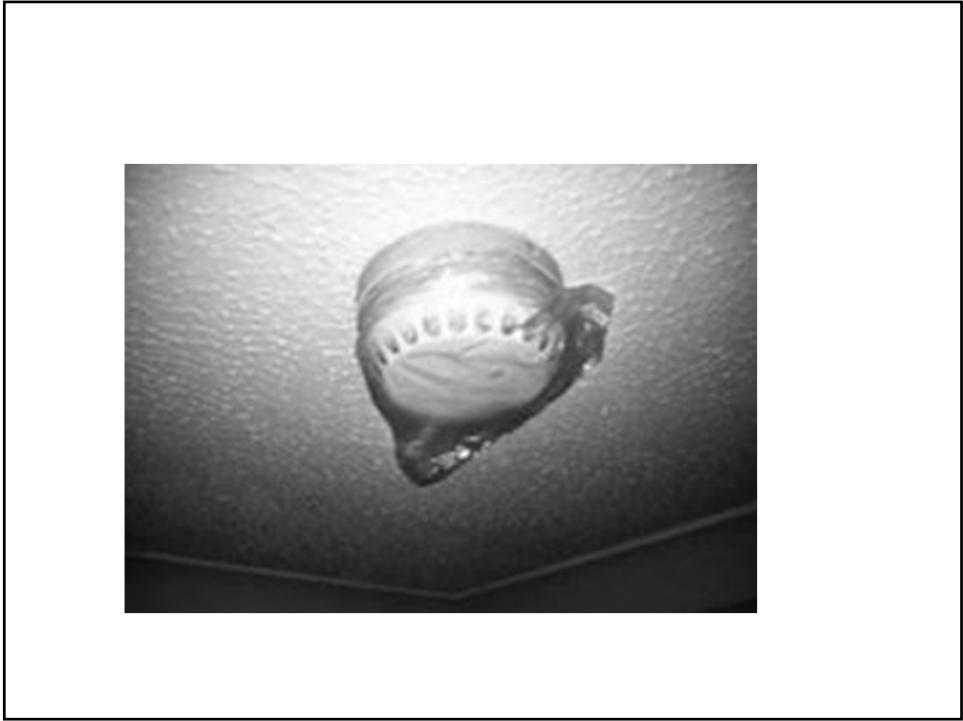
Deficiency 3: Carbon monoxide alarm does not produce an audio or visual alarm when tested.

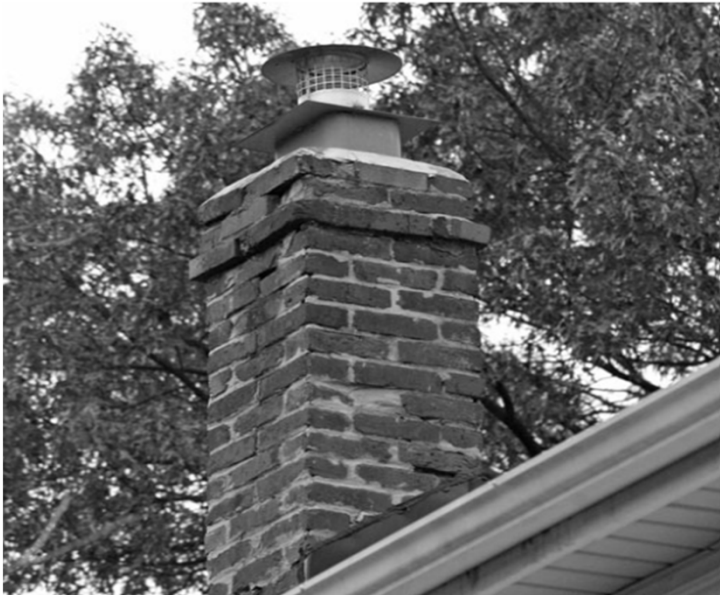
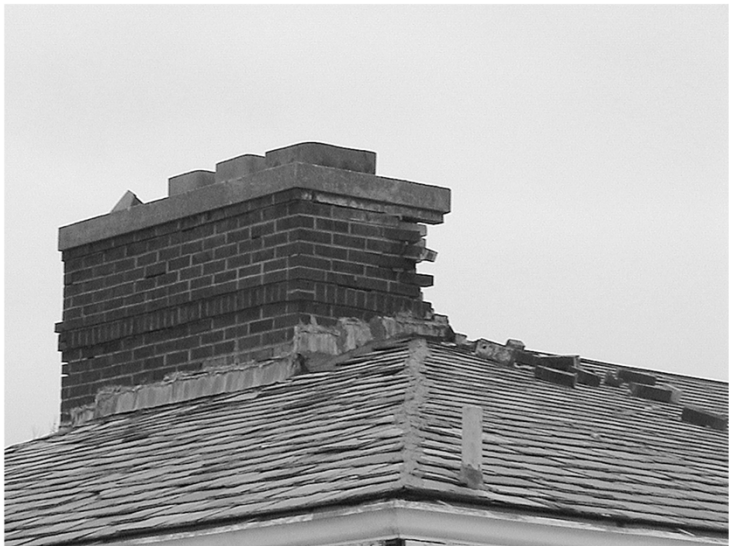
Deficiency 2: Chimney exhibits signs of structural failure.

- Outside:
- Examples of chimney structural failure include, but are not limited to:
    - Misaligned
    - Detached
    - Leaning away from the building
    - Collapsed
    - Imminent danger of collapse

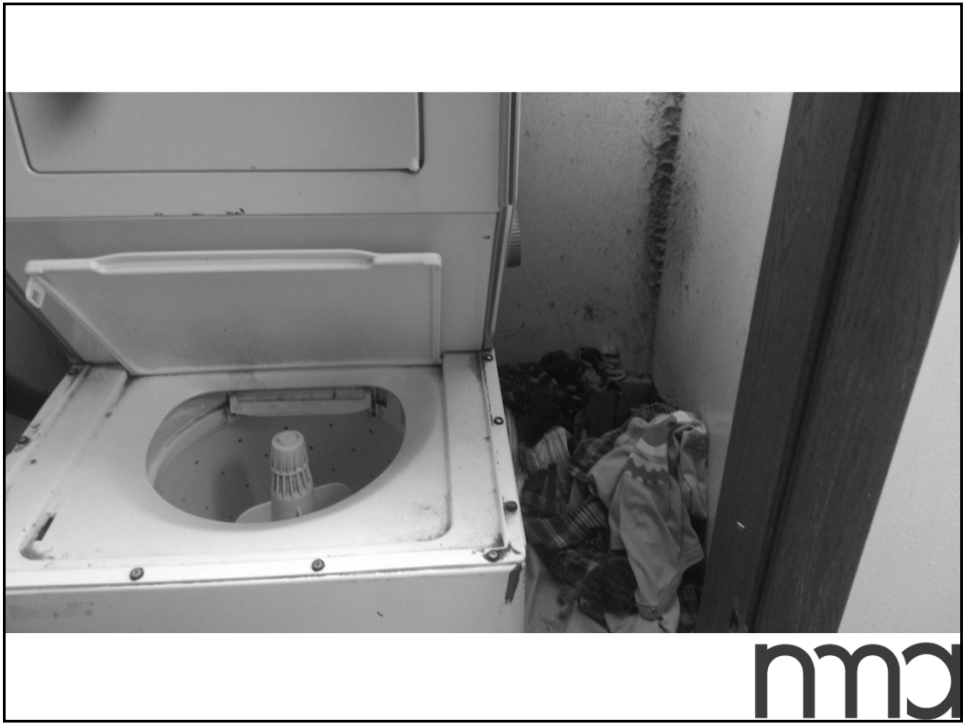
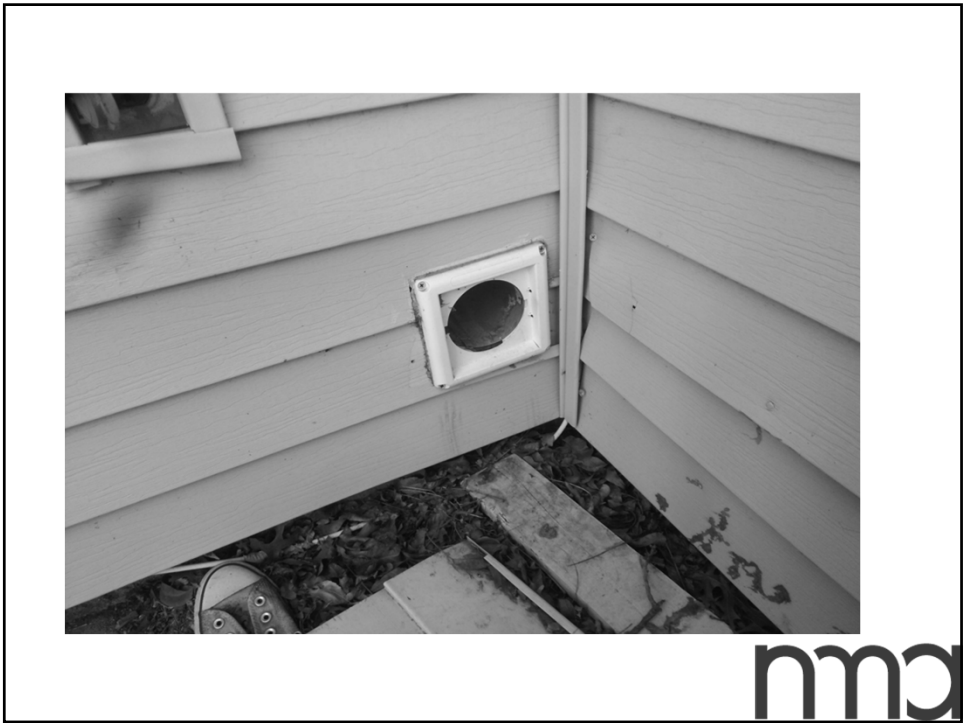
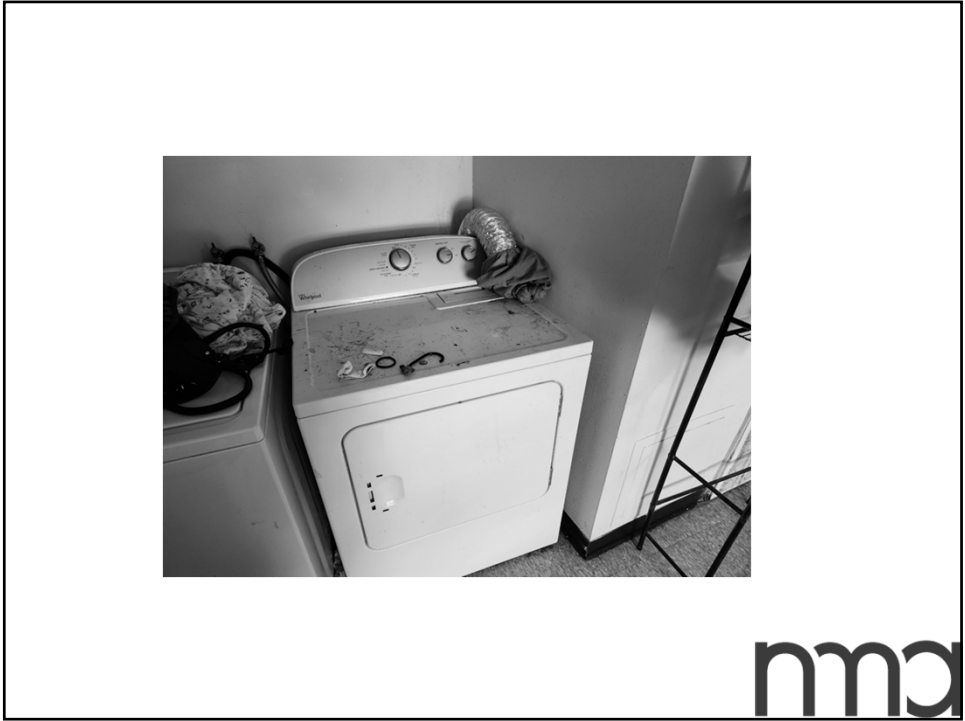
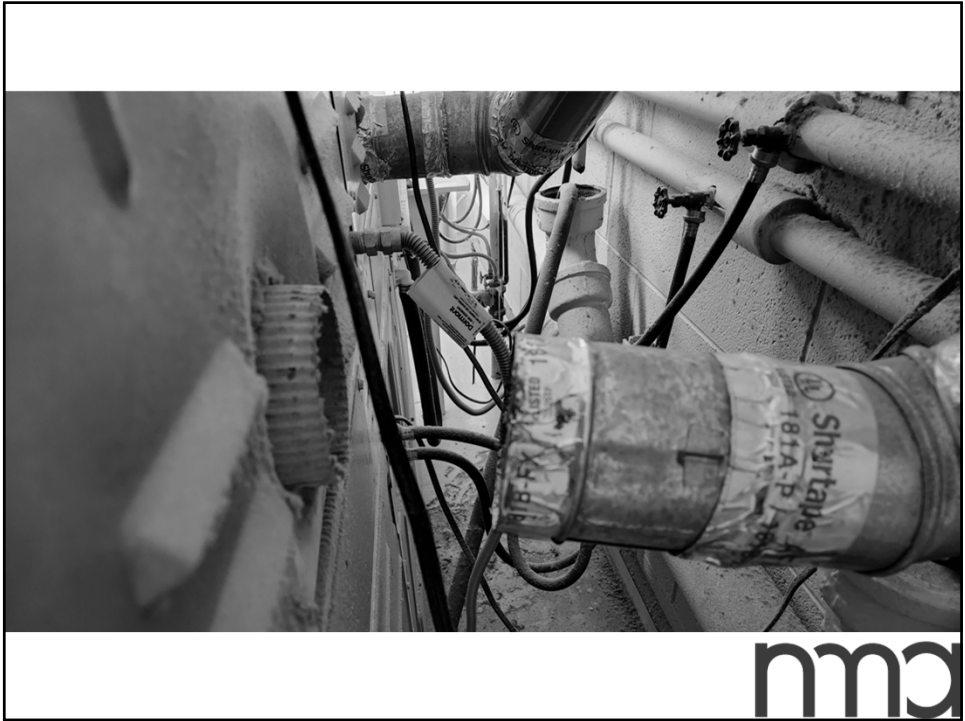
Deficiency 1: Electric dryer transition duct is detached or missing.

| Unit, Inside, & Outside: | <ul style="list-style-type: none"><li>Improvised filter materials (e.g., stockings, t-shirts, etc.) attached to the duct line are considered a blockage and should be recorded as a deficiency.</li></ul> |

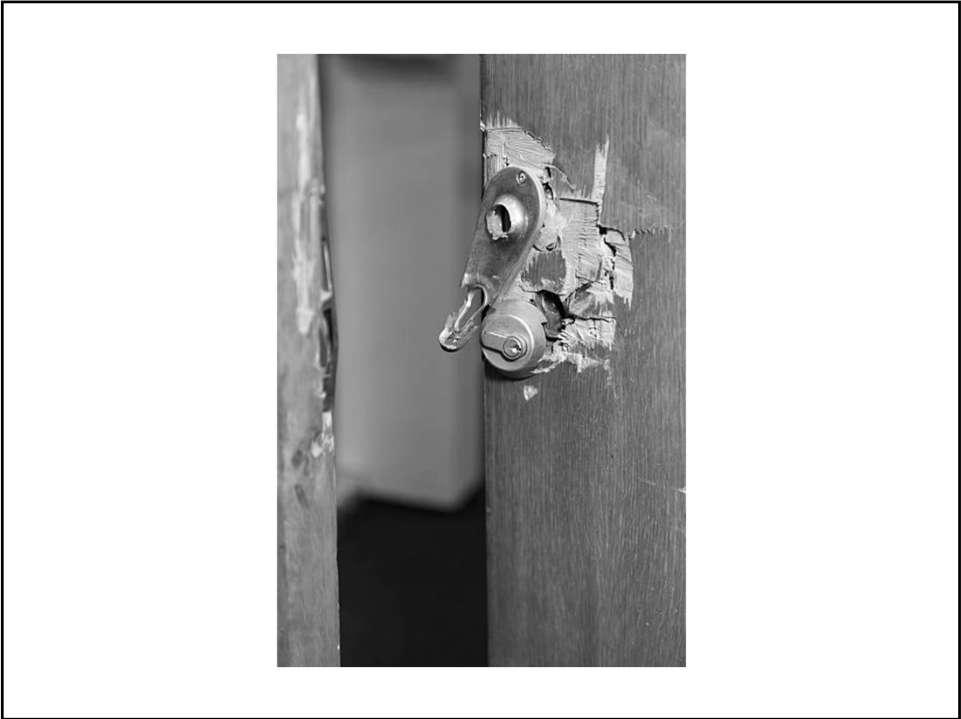
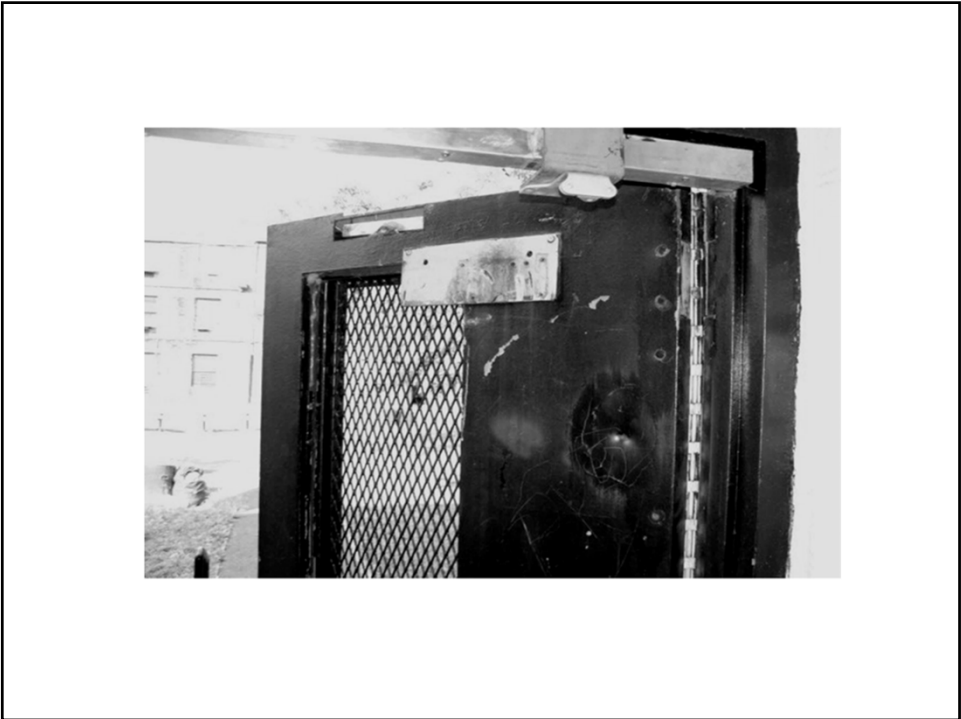
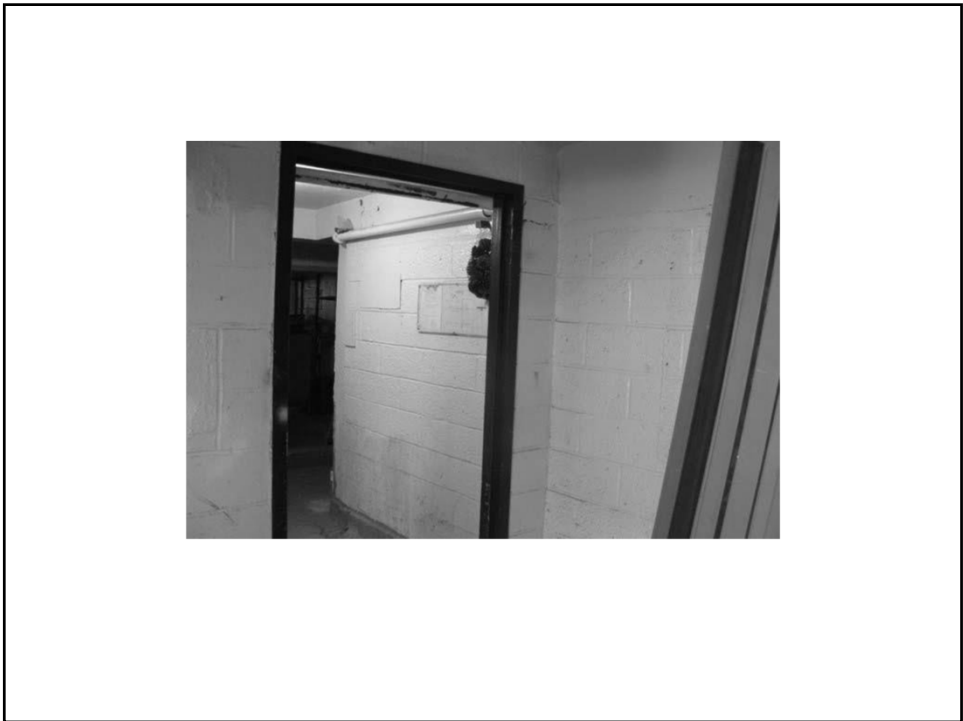
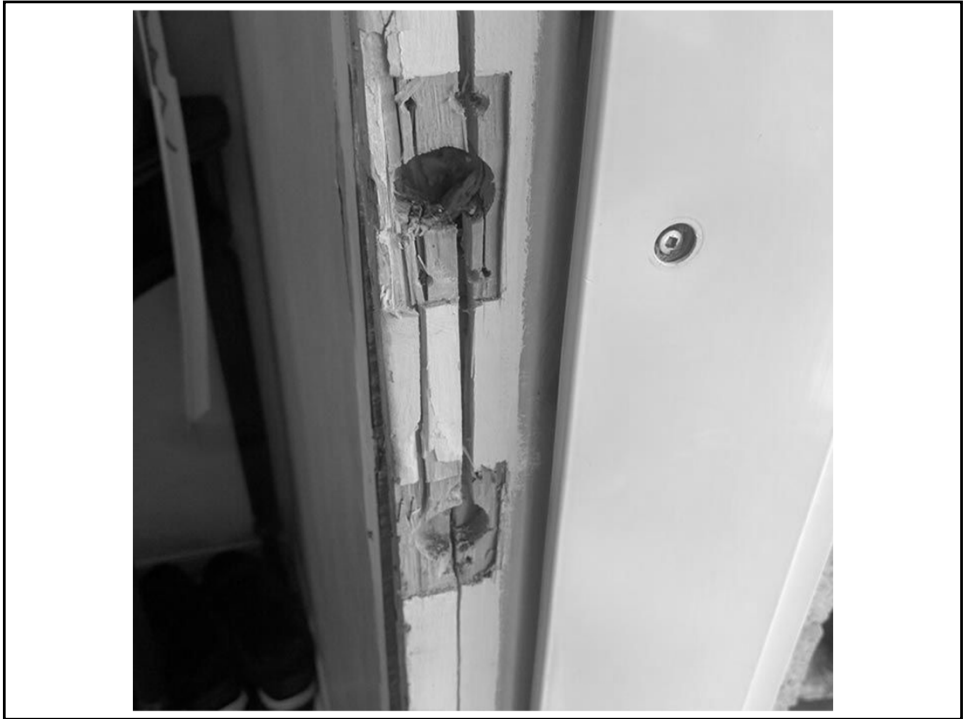
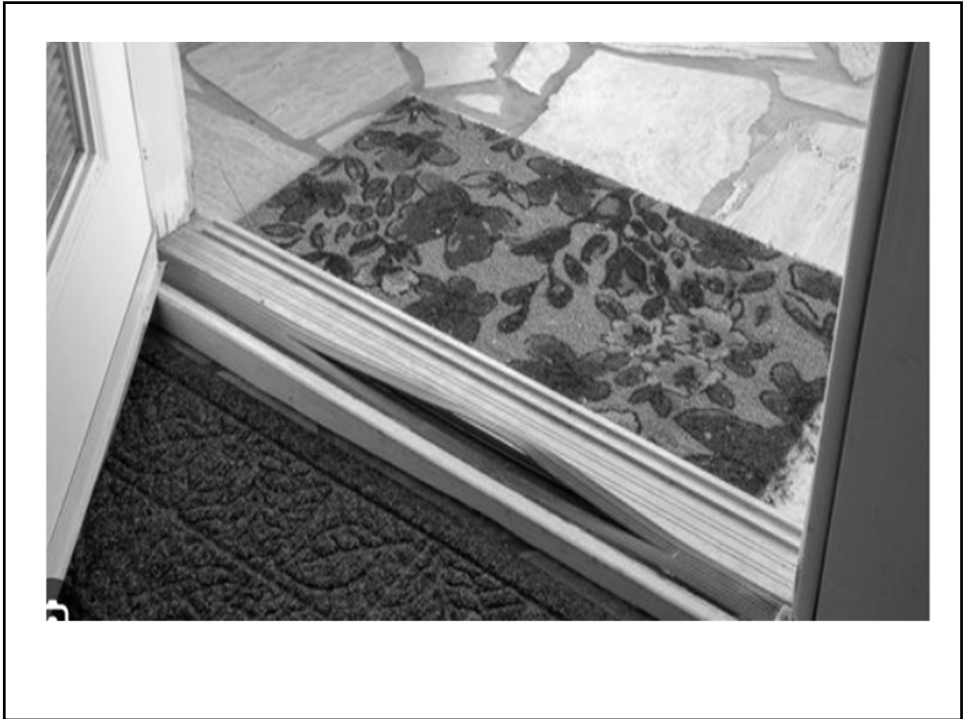
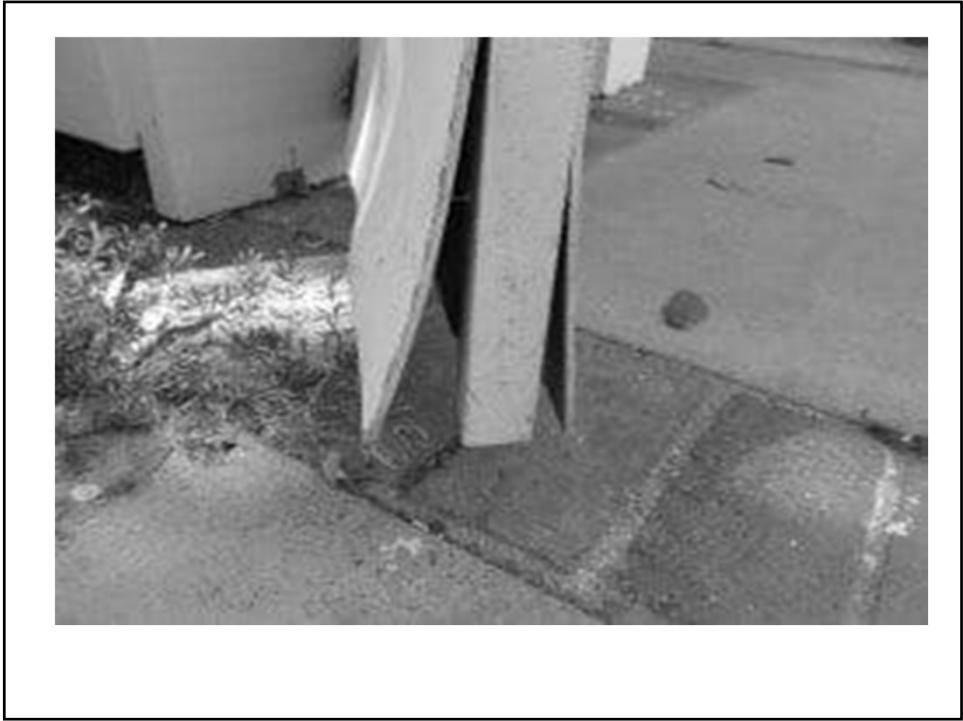
# Door – Entry

- Examples may include, but are not limited to:
  - Insulated glass with a compromised seal;
  - Auxiliary (i.e., additional) installed lock;
  - Installed security device;
  - Strike plate or latch assembly;
  - Weather stripping on an entry door that provides access to the Unit from the Inside (e.g., hallway); or
  - Casing or decorative trim.

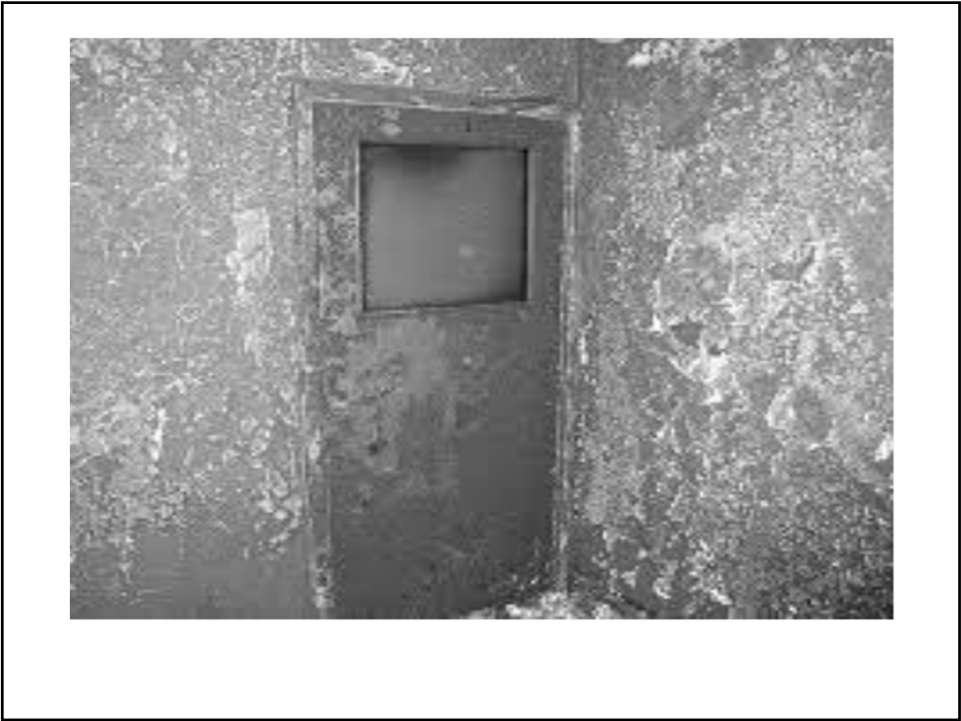
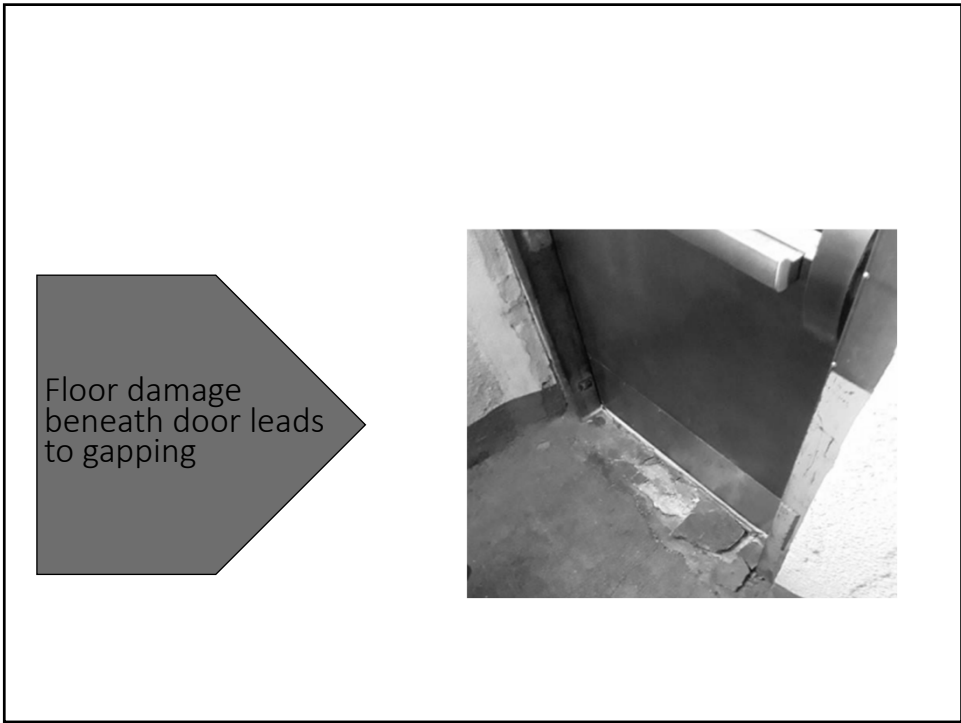
# Door – Fire Labeled

| Definition: | A door with a fire-resistant rating (i.e., the time within which materials or assemblies have withstood fire exposure). |

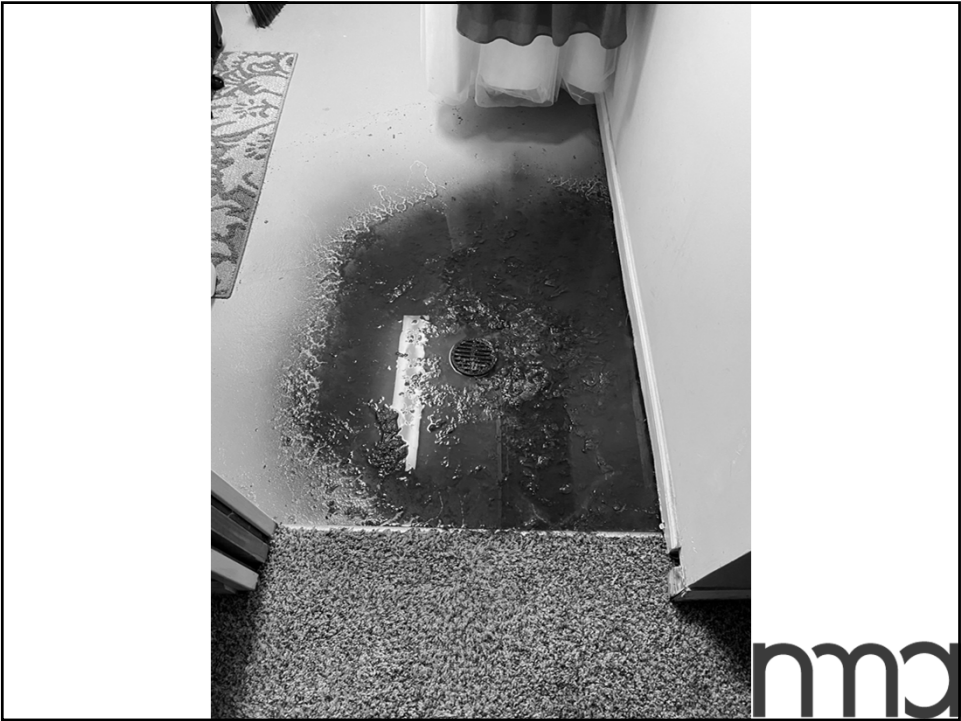
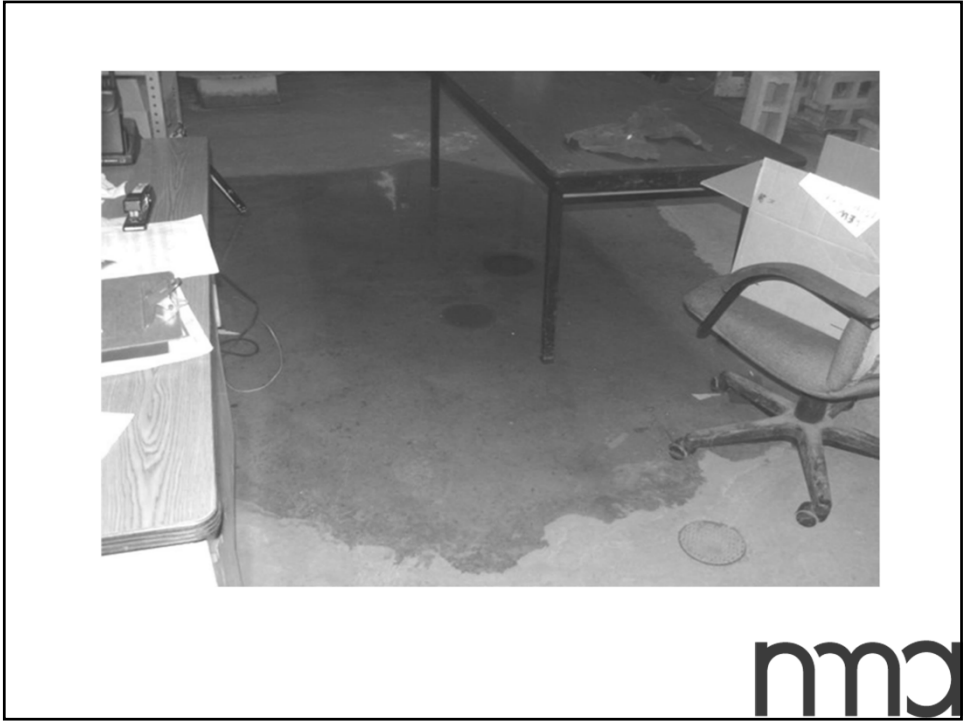
# Drain

| Deficiency 1: Drain is fully blocked. | |
| Unit, Inside, & Outside: | <ul style="list-style-type: none"><li>This deficiency applies to floor drains attached to the sanitary drainage system.</li></ul> |

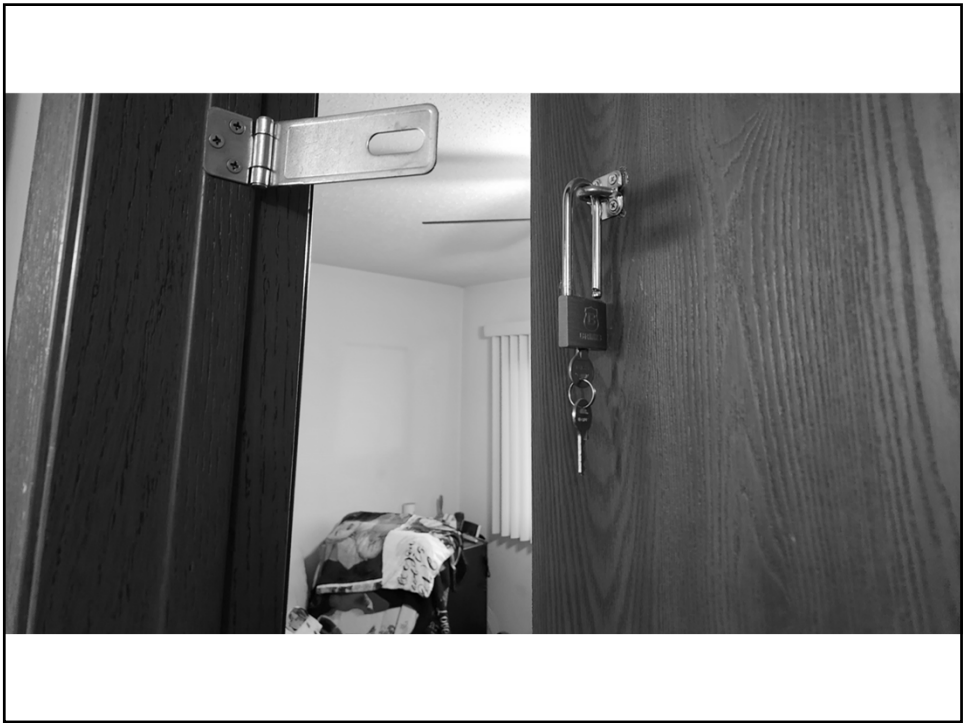
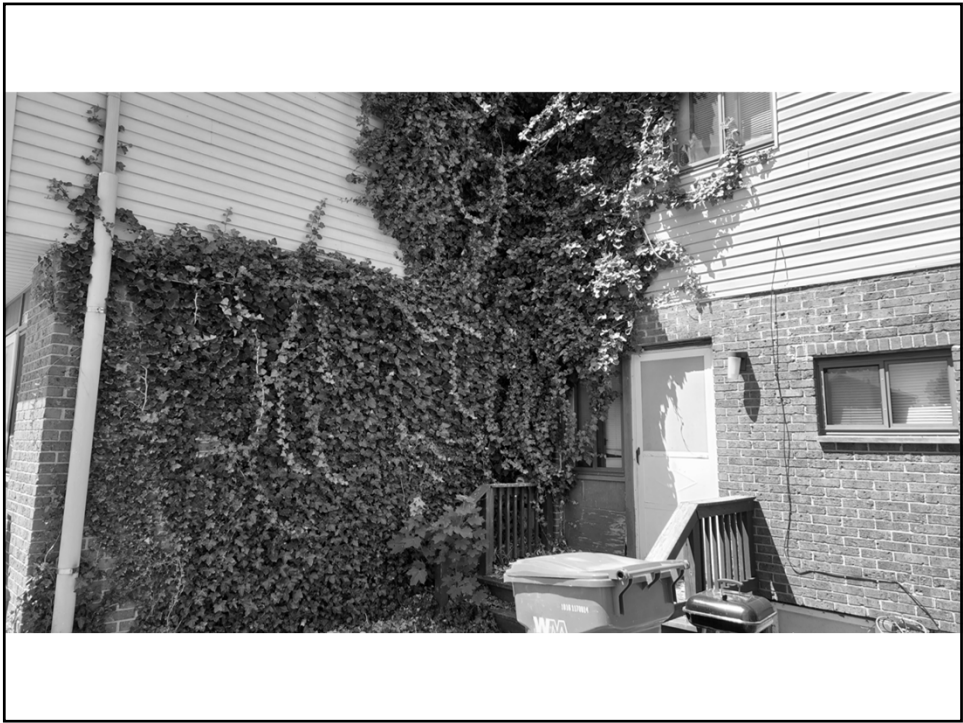
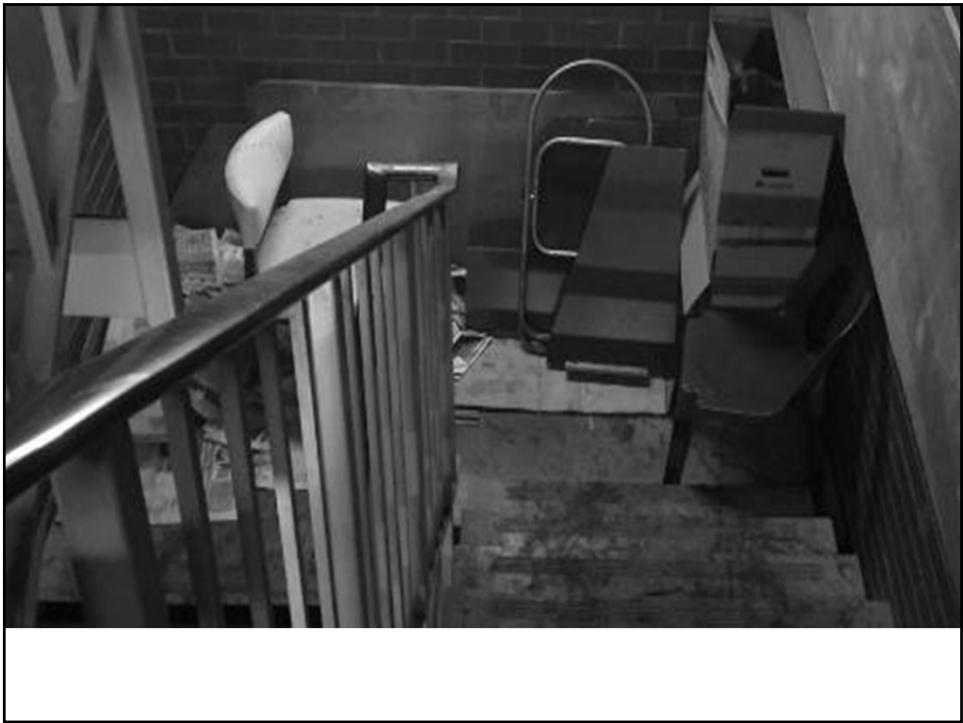
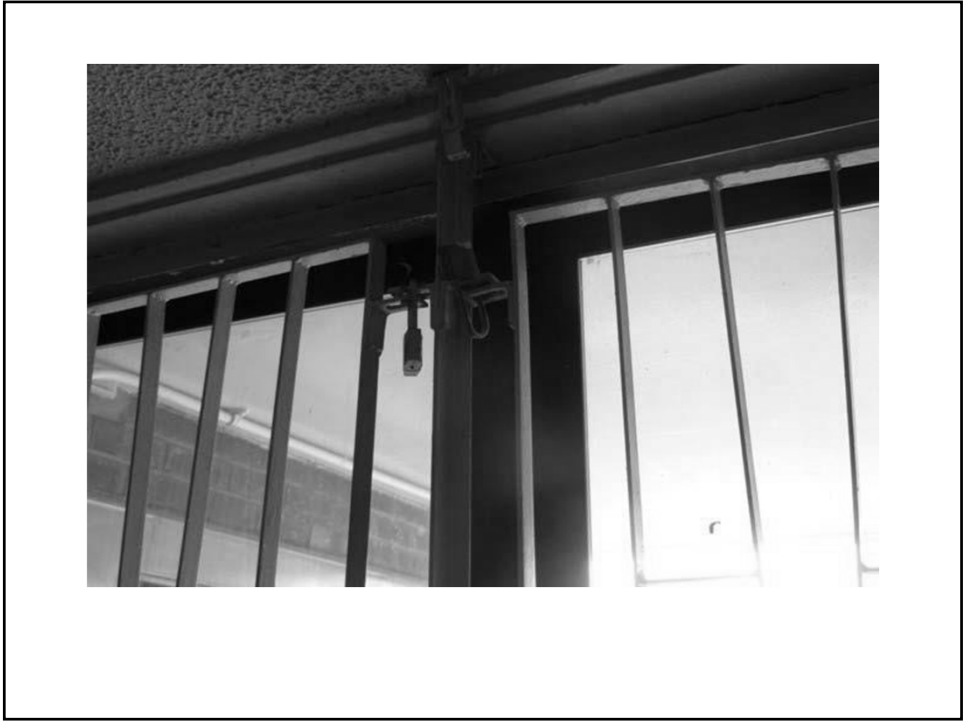
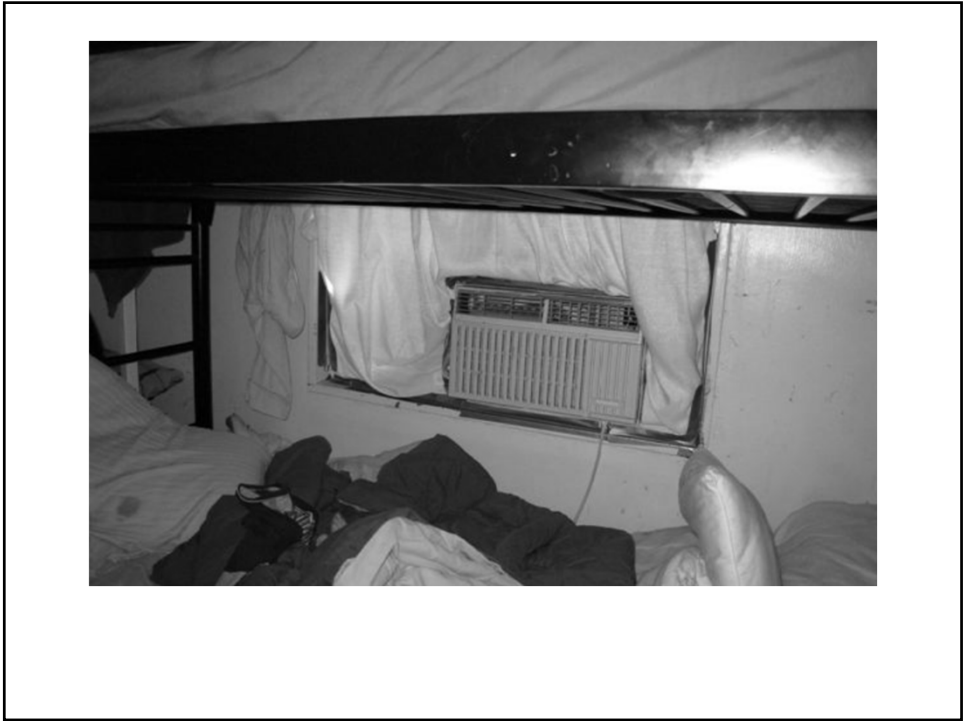
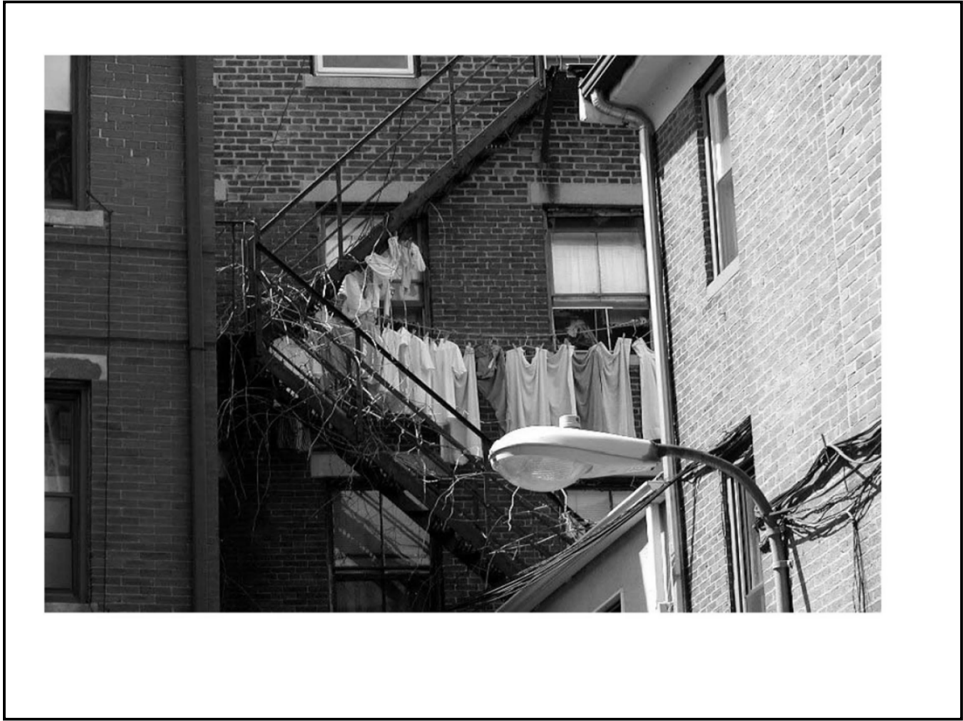
# Egress

| Deficiency 1: Obstructed means of egress. | | | |

- The following are examples of conditions on doors that may obstruct means of egress:
  - Double key cylinder deadbolt locks or any lock that requires a key, a tool, or special knowledge or effort to operate (from the egress side) are not allowed on any door that serves as an exit or any door along the exit access.
  - Double key cylinder lock on a bedroom door.
  - When fixed security bars are present that cover a door that is the designated means of egress from the building.
  - Any lock on movable security bars for doors requiring a key (special tool) to open, whether locked or unlocked at the time of inspection.
  - Placement of an item or furniture that obstructs a means of egress.

- A keyed exterior gate or fence is considered a condition that may obstruct the means of egress.
- If an item located on the outside is obstructing access to the fire escape, then evaluate under this deficiency.

Deficiency 2: Sleeping room is located on the 3<sup>rd</sup> floor or below and has an obstructed rescue opening.

| Deficiency 3: Fire escape access is obstructed. | |

| Unit: | <ul style="list-style-type: none"><li>• Resident-owned property should not be evaluated as an obstruction to the fire escape access.</li><li>• The following are examples of conditions on windows that may obstruct fire escape access:<ul style="list-style-type: none"><li>• Window locks that require a key, a tool, or special knowledge or effort to operate (from the interior).</li><li>• When fixed security bars are present that cover a window that provides fire escape access.</li><li>• Any lock on movable security bars for windows requiring a key (special tool) to open, whether locked or unlocked at the time of inspection.</li><li>• Placement of an item or furniture that is not resident owned and obstructs fire escape access.</li><li>• A permanently installed window-mounted air conditioner.</li></ul></li></ul> |

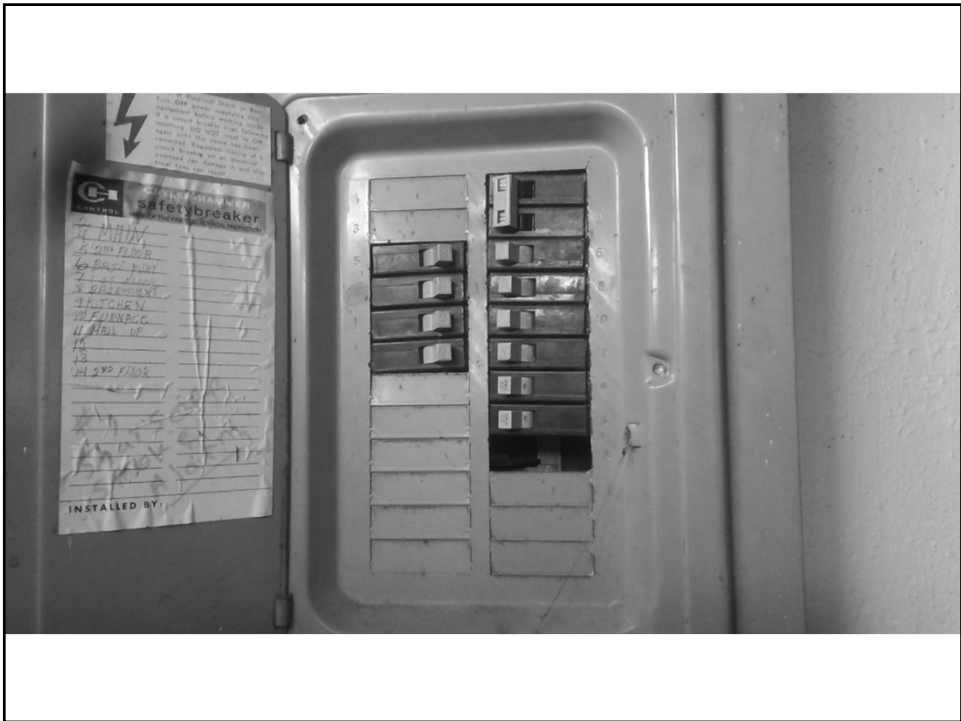
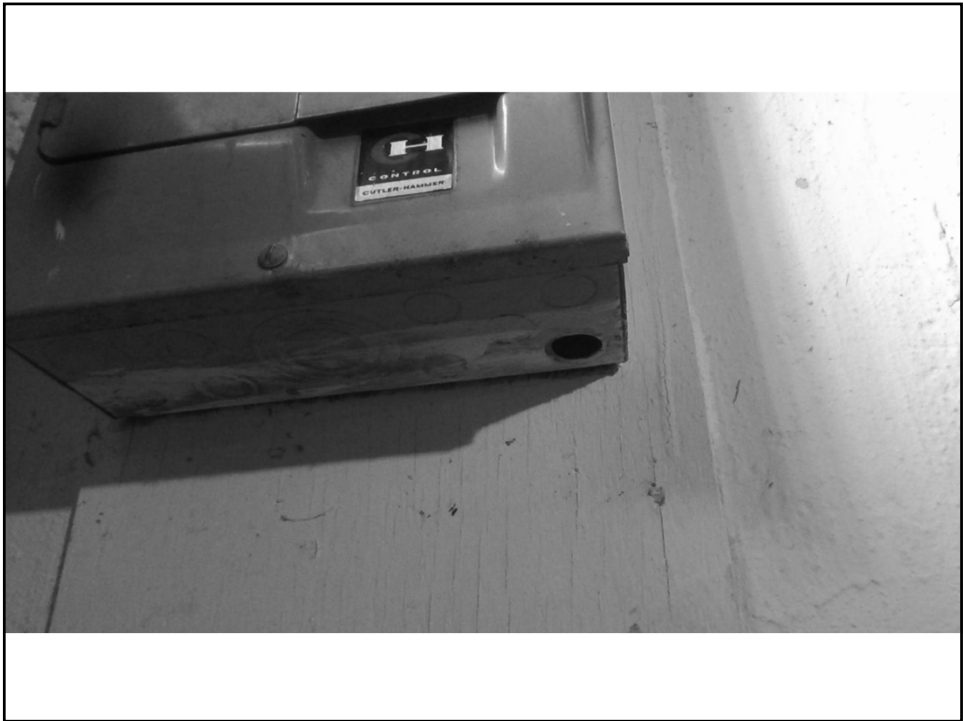
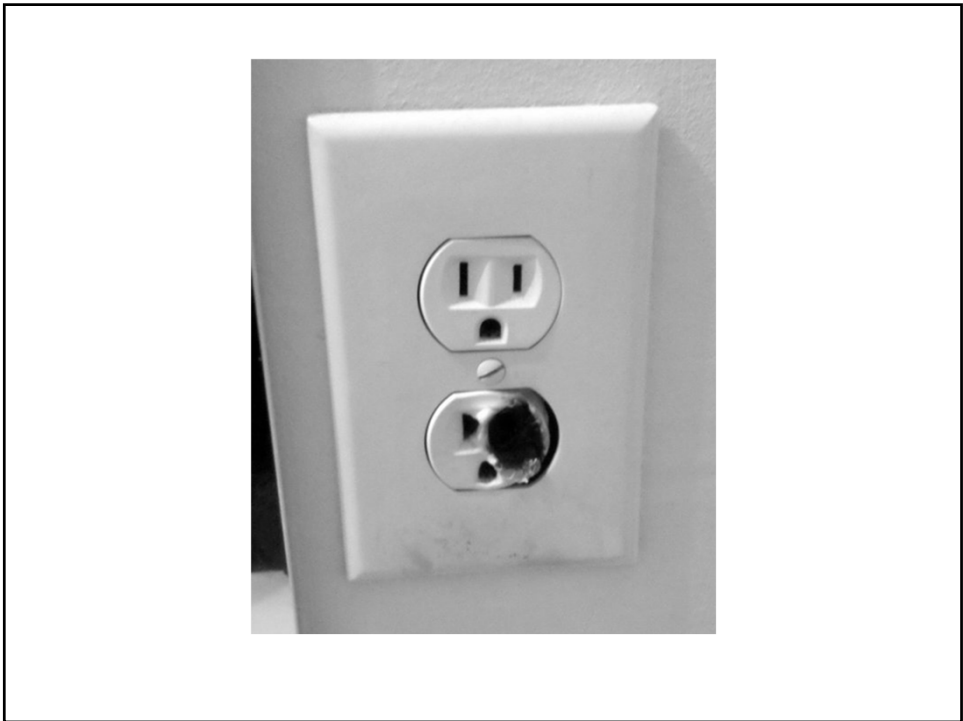
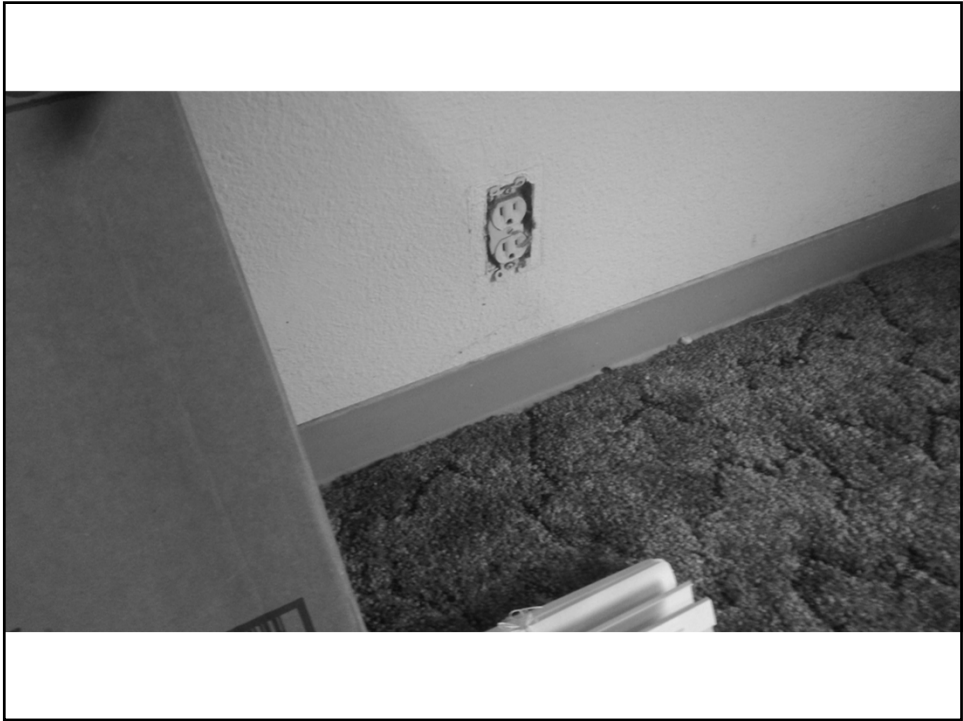
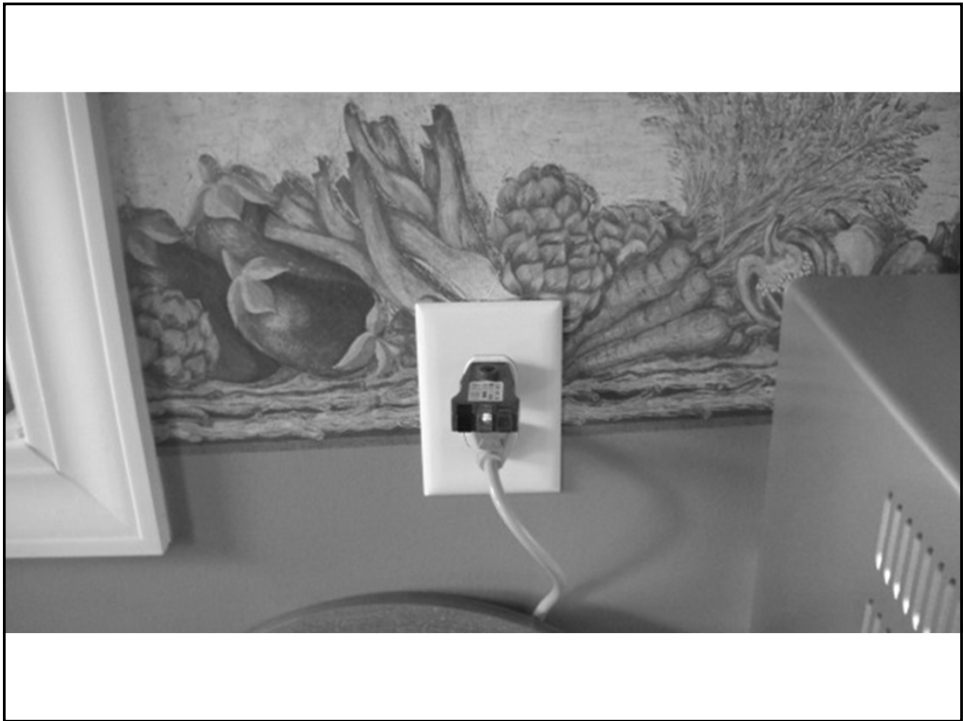
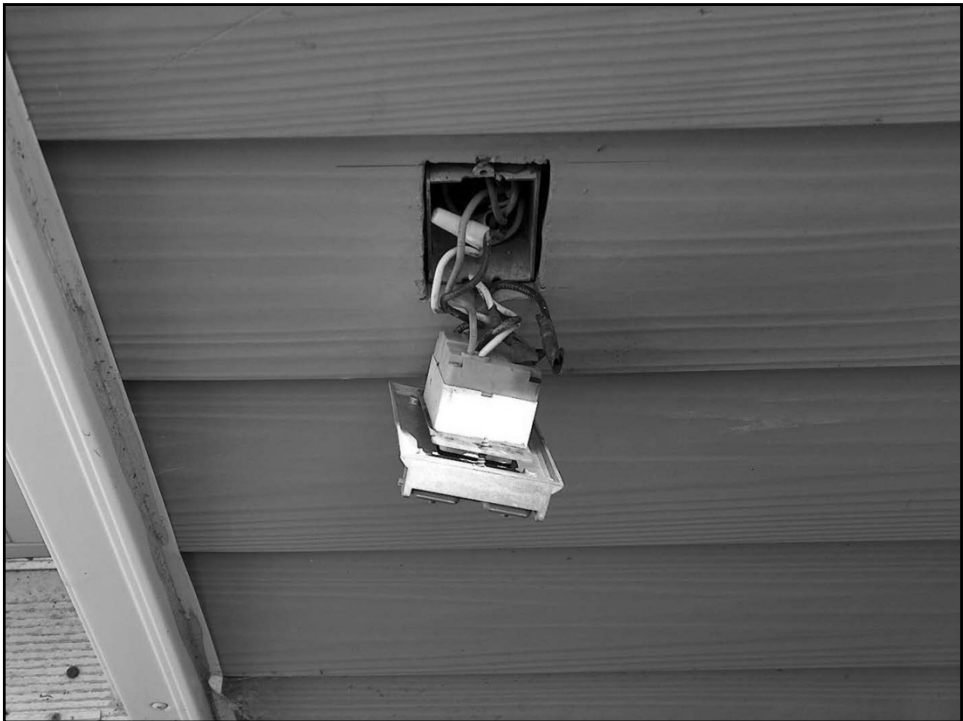
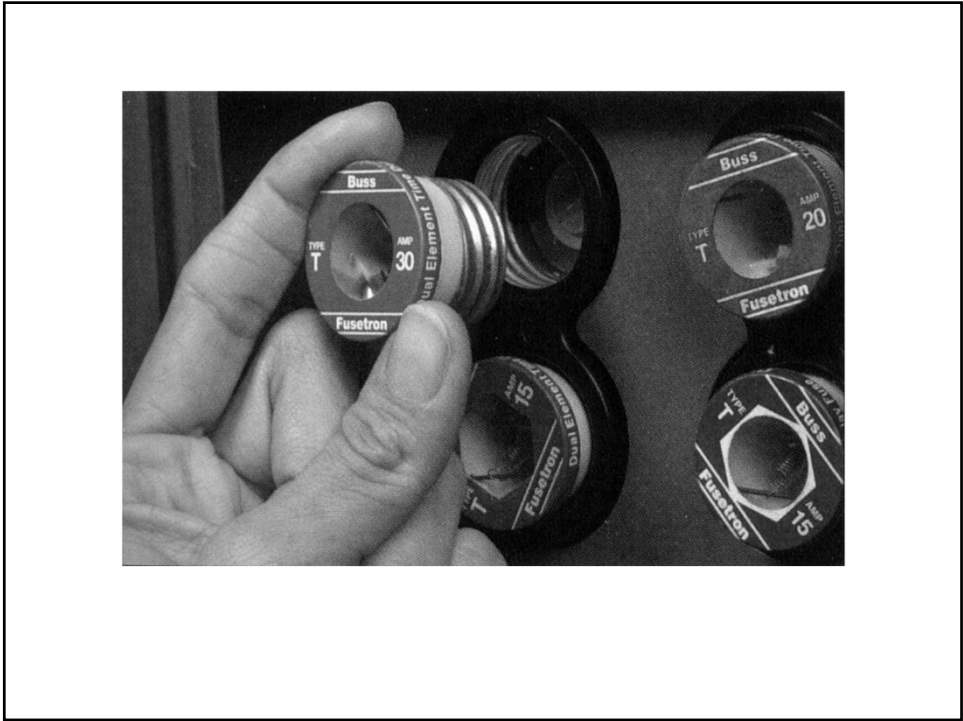
# Electrical – Conductor, Outlet, and Switch

Deficiency 1: Outlet or switch is damaged.

| Unit, Inside, & Outside: | Any portion of a visually accessible (i.e., can be reasonably accessed and observed) outlet or switch is damaged (i.e., visibly defective; impacts functionality) such that it may not safely carry or control electrical current at the outlet or switch. |

**Deficiency 2:** Testing indicates a three-pronged outlet is not properly wired or grounded.

**Deficiency 3:** Outlet does not have visible damage and testing indicates it is not energized.

Deficiency 4: Exposed electrical conductor.
