# NSPIRE for Housing Choice Voucher PowerPoints Day 1

**NSPIRE for HCV  
(NSPIRE-V)  
Day 1**

**Chapter 1  
Introduction**

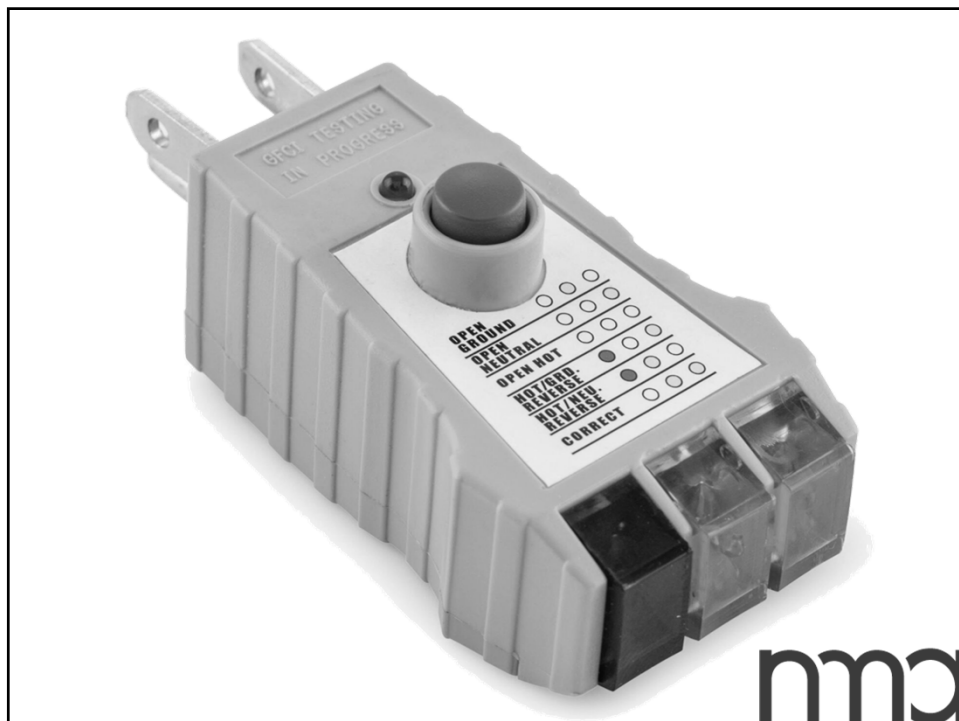
## Electrical – GFCI or AFCI – Outlet or Breaker

- HUD allows the use of either a receptacle tester with a GFCI test button or the integral device tester
- HUD does not plan to prescribe a specific tool that inspectors must use but will include a list of tools that meet industry standards

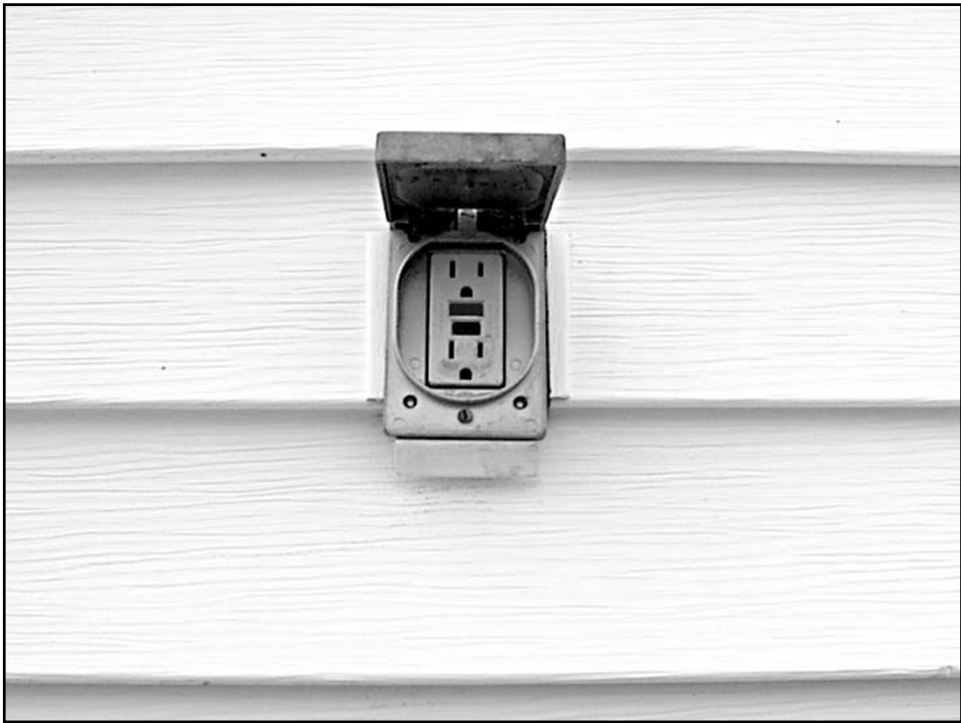
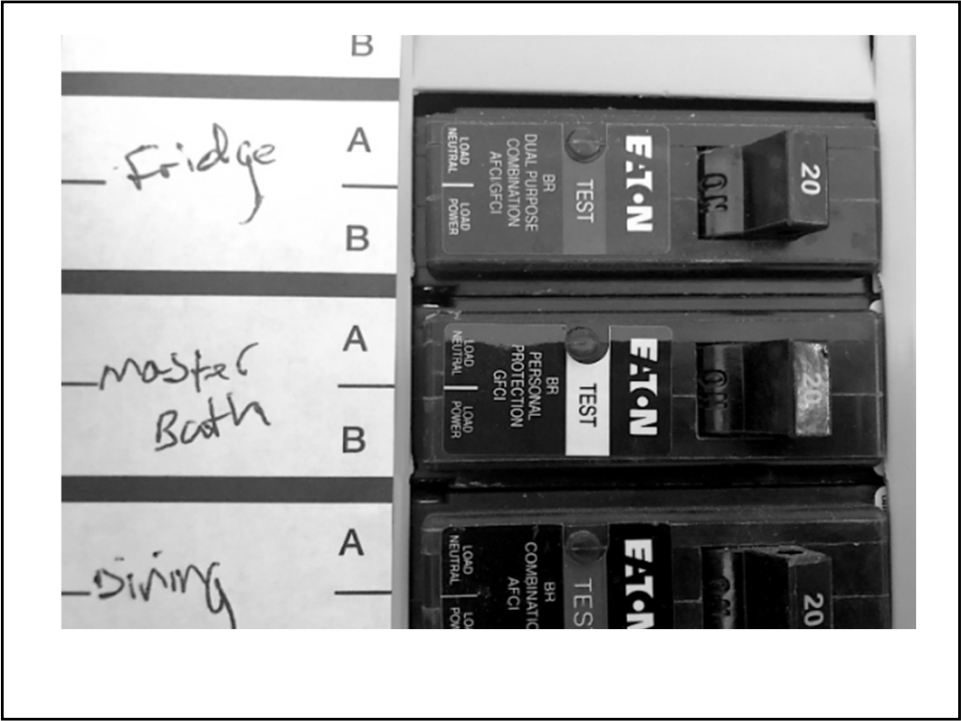
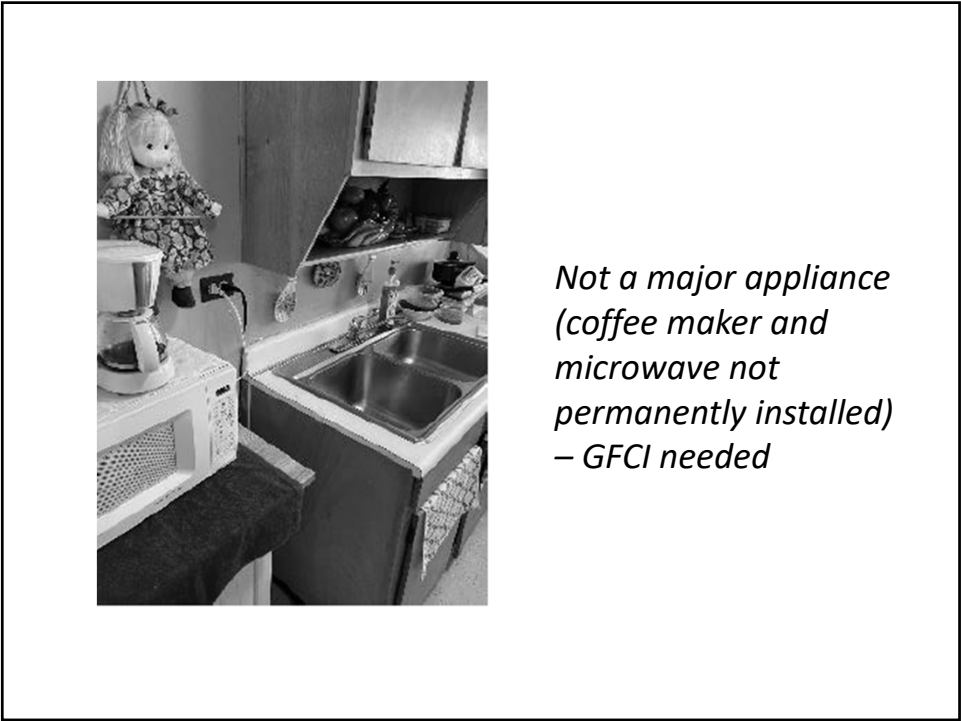
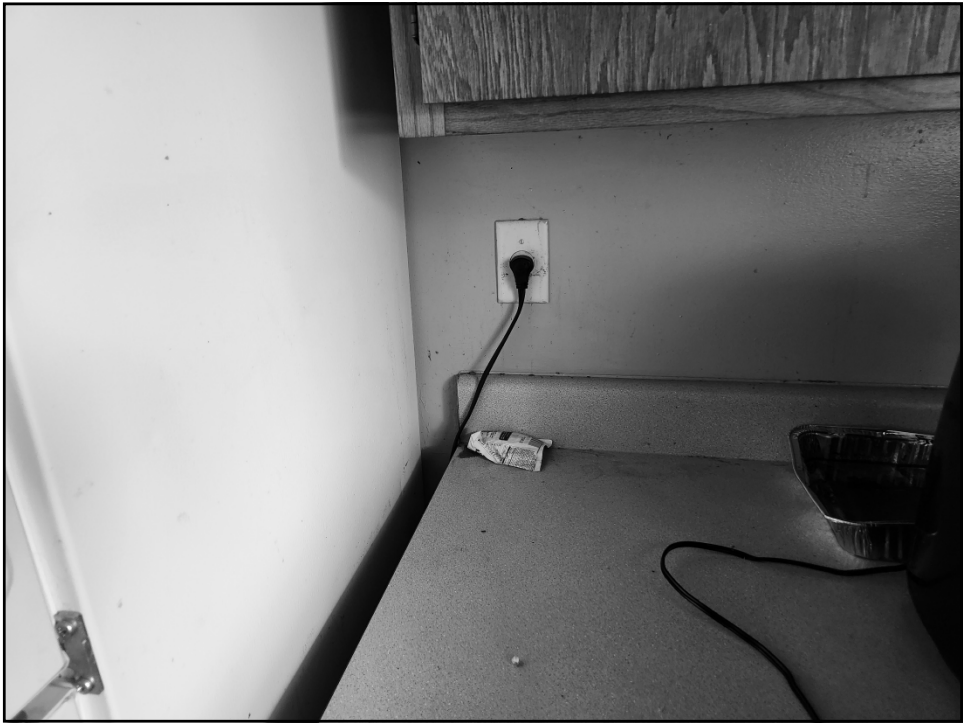
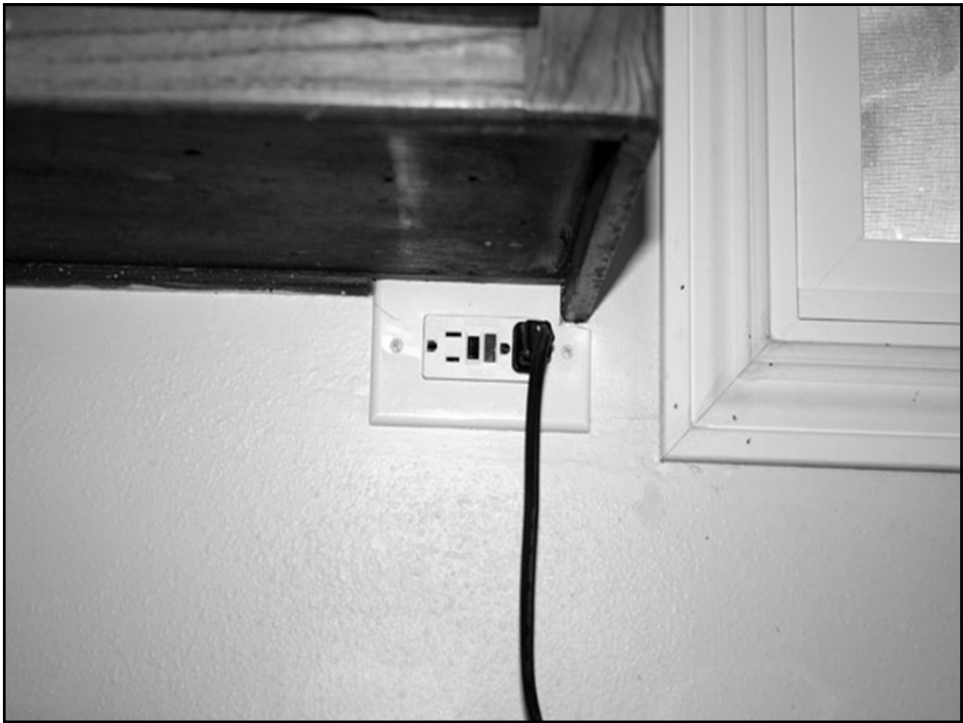
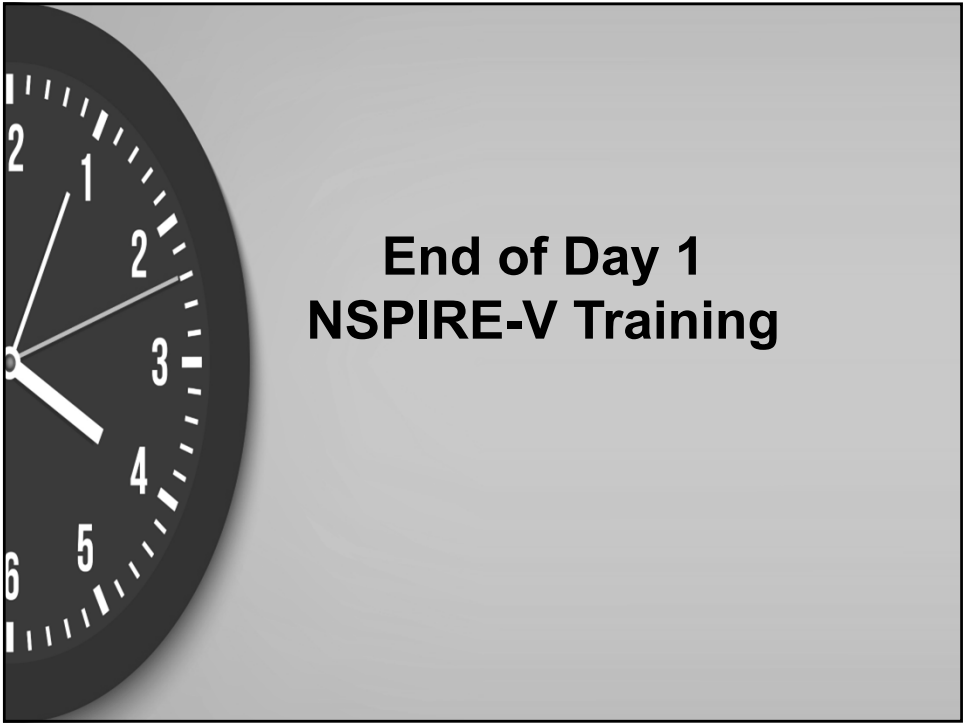
**Electrical – GFCI or AFCI –  
Outlet or Breaker**

| Outside: | <ul style="list-style-type: none"><li>• Outlet protection methods include GFCI outlet, GFCI breaker, or an outlet wired in series that is protected by another GFCI outlet.</li><li>• An electrical conductor that is not enclosed or properly insulated should be evaluated under the Electrical – Conductor, Outlet, and Switch standard.</li></ul> |
