NSPIRE for Housing Choice Voucher PowerPoints Day 3

**NSPIRE for HCV
(NSPIRE-V)
Day 3**

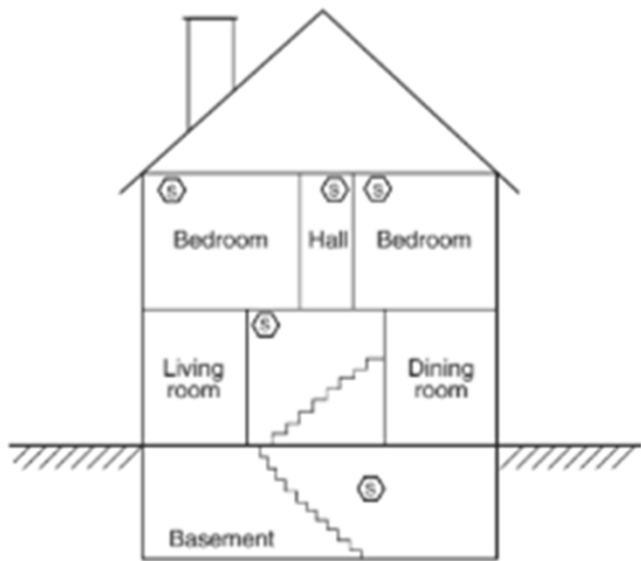
FIGURE A.29.8.1(d) Smoke Alarm Should Be Located on Each Level in Addition to Each Bedroom.

- **The unit must include at least one sealed battery-operated or hard-wired smoke detector, in proper working condition, in the following locations:**
 - **On each level of the unit;**
 - **Inside each bedroom;**
 - **Within 21 feet of any door to a bedroom measured along a path of travel; and**

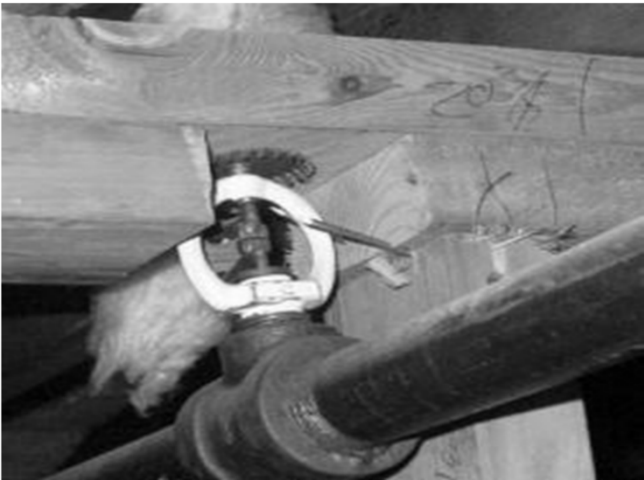
Deficiency 4: Sprinkler assembly has evidence of foreign material that is detrimental to performance.			
Deficiency Criteria:			
Unit, Inside, & Outside:	Foreign material covers 75% or more of the sprinkler assembly. OR Foreign material covers 75% or more of the glass bulb.		
H&S Determination:		Correction Timeframe:	
Unit, Inside, & Outside:	Life-Threatening / Fail	Unit, Inside, & Outside:	24 hours
More Information:			
Unit, Inside, & Outside:	<ul style="list-style-type: none">For the purpose of this Standard, a condition is detrimental to performance if it impacts the sprinkler assembly's ability to properly or adequately discharge when activated.Examples of foreign material that may be detrimental to performance may include, but are not limited to:<ul style="list-style-type: none">Loading / dustPaint

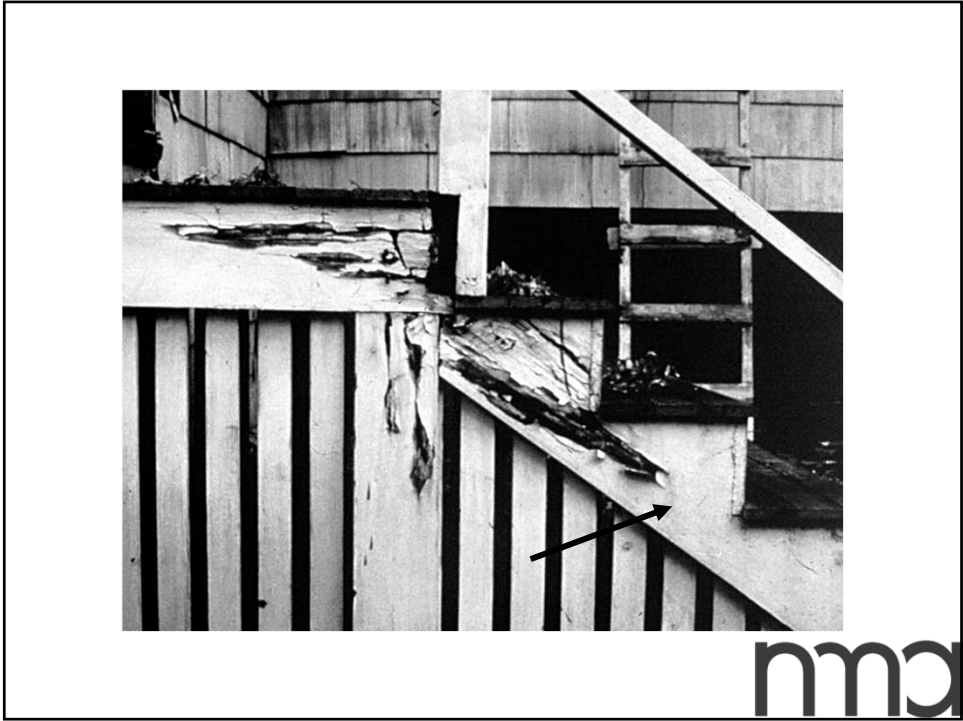
- Conditions that may impact the functional adequacy of a step or stairs may include, but are not limited to:
 - Damage or deterioration to the extent that it disrupts a person's ability to move from one level to the next
 - Unintentional dimensional changes that may interrupt a person's walking pattern or movement
 - Unstable material

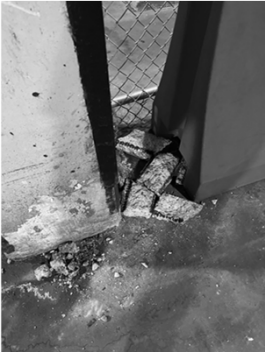
*Not a Structural
System deficiency*

*Rotted floor,
almost fell through*

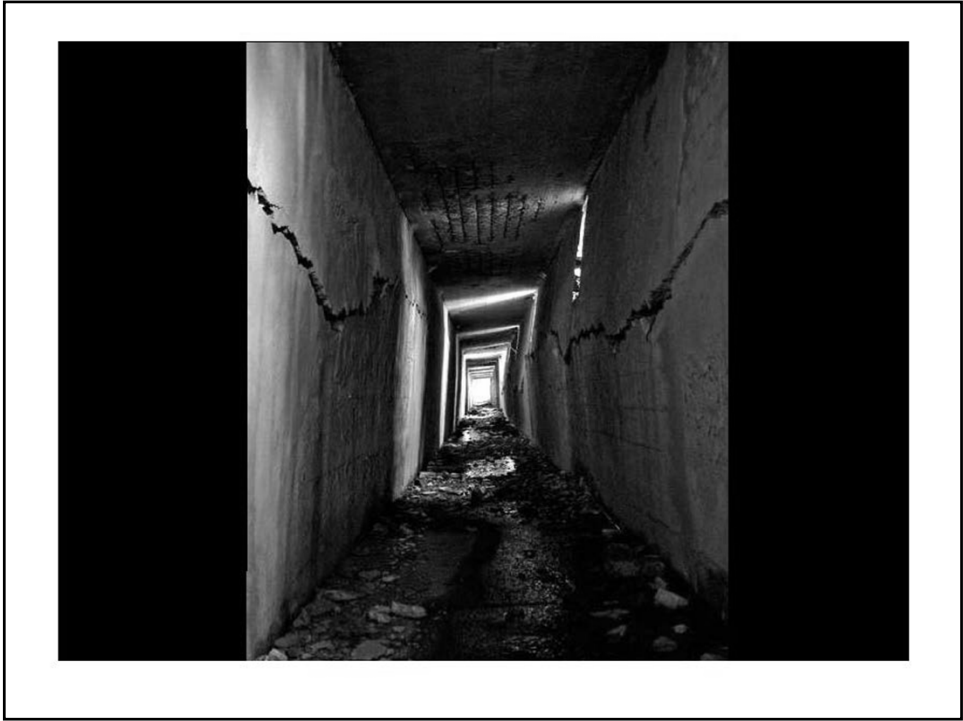
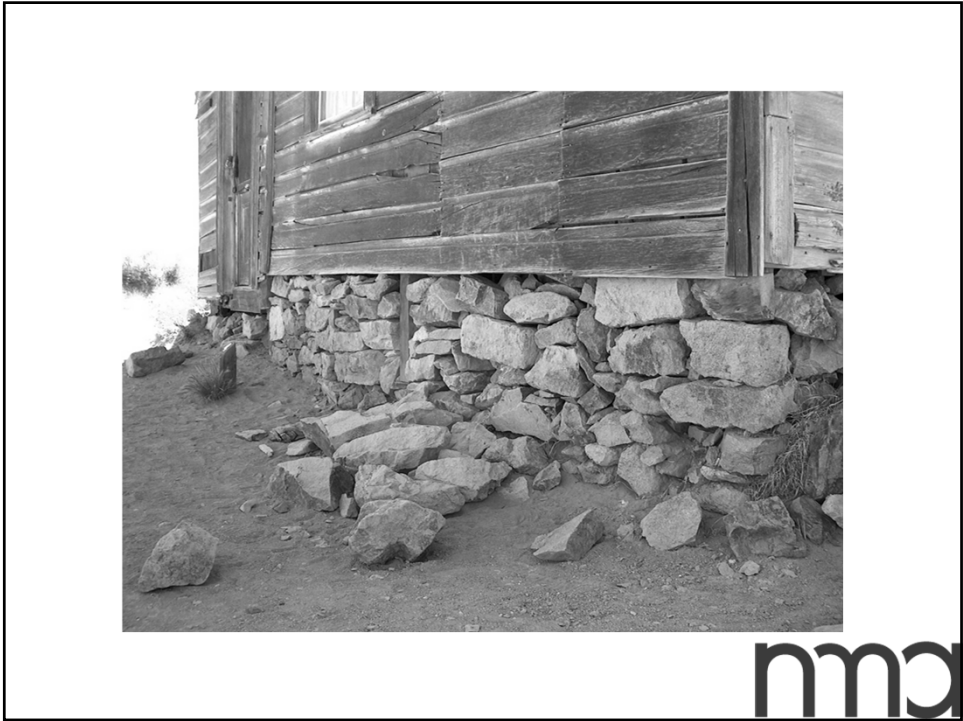
*Structural System
deficiency*

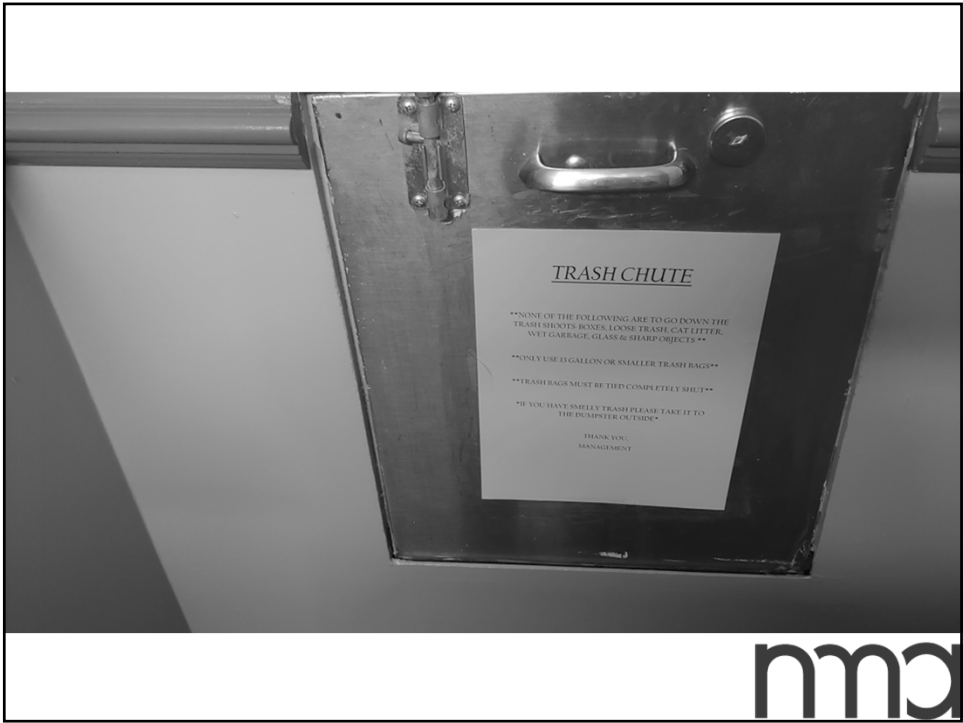
Definition:	A large tube through which refuse is carried by means of gravity to a large waste receptacle at the bottom end.
Common Components:	Chute; Door; Latch; Compactor; Chute discharge fire door with fusible link; Wash valve; Spray head; Springs; Handle; Counterbalance
More Information:	None

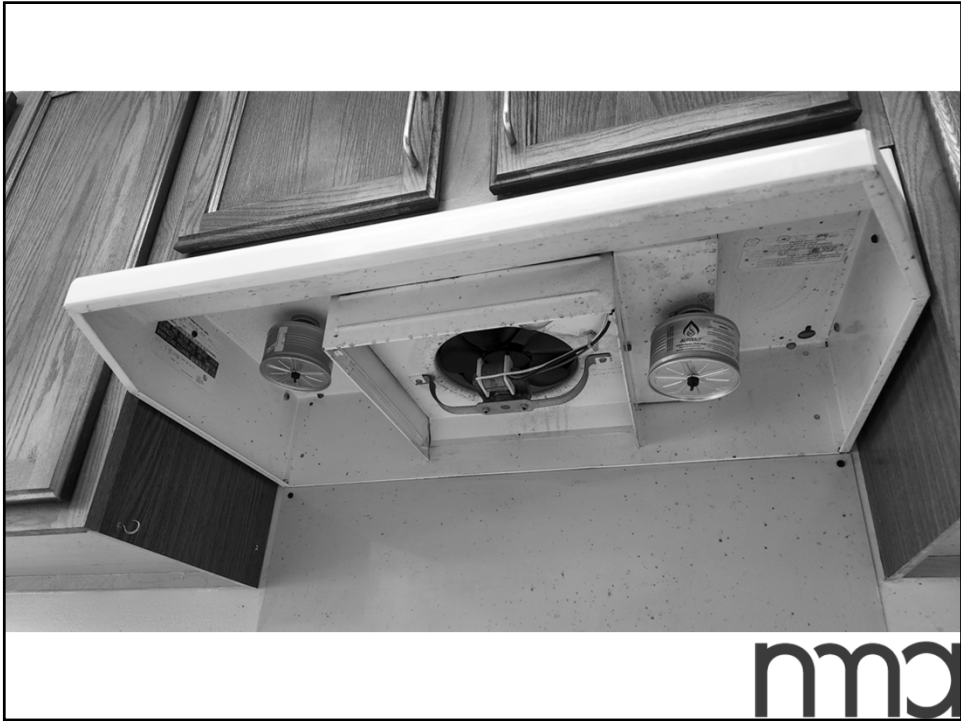
Deficiency 4: Bathroom does not have proper ventilation or dehumidification.	
Deficiency Criteria:	
Unit & Inside:	Neither an exhaust fan, window, nor adequate means of ventilation or dehumidification is present and operable.
H&S Determination:	
Unit & Inside:	Moderate / Fail
Correction Timeframe:	
Unit & Inside:	30 days
More Information:	
Unit & Inside:	<ul style="list-style-type: none">• A high-rise building may have a passive or motorized central ventilation system and if there is a vent in the bathroom, this may require an alternate means of detecting airflow if otherwise undetectable.• The POA is allowed to plug in an exhaust fan if it is present and unplugged.• Only one means of ventilation or dehumidification is required per bathroom.

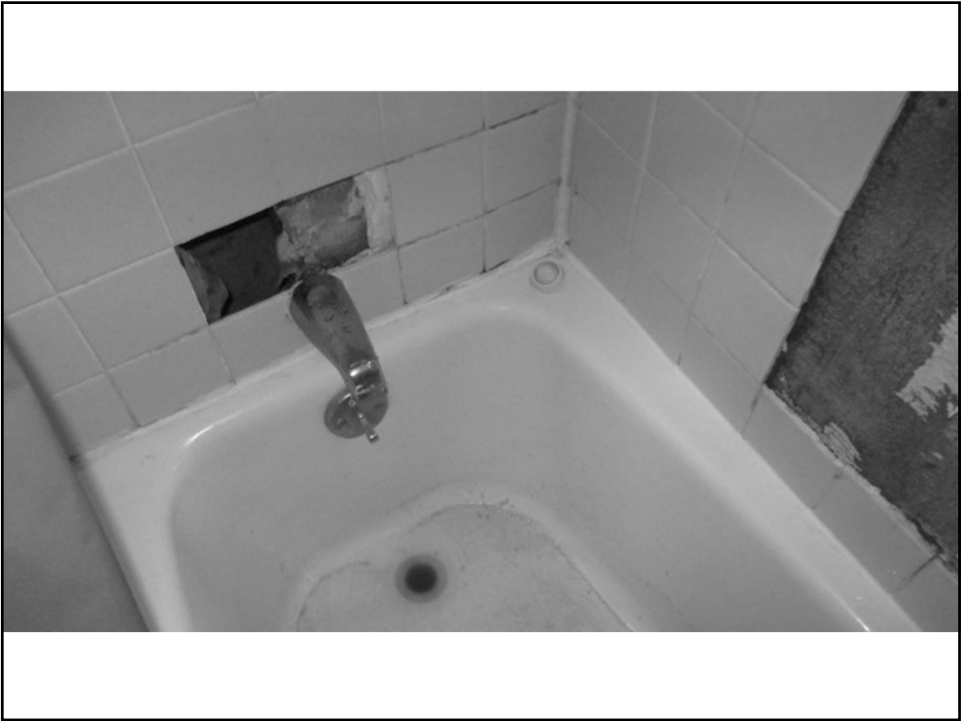
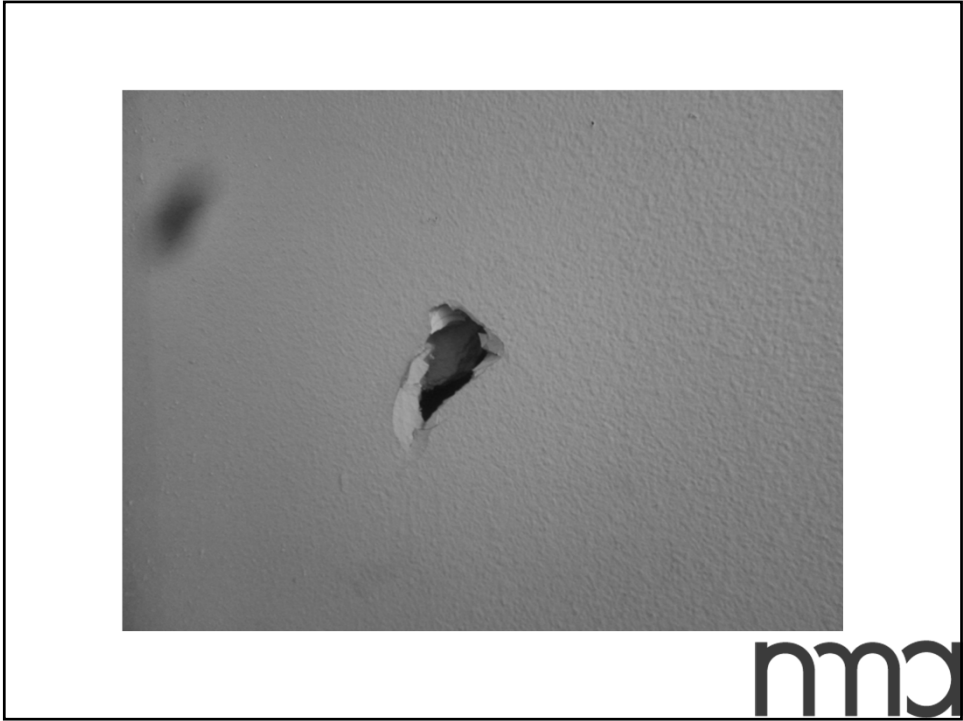
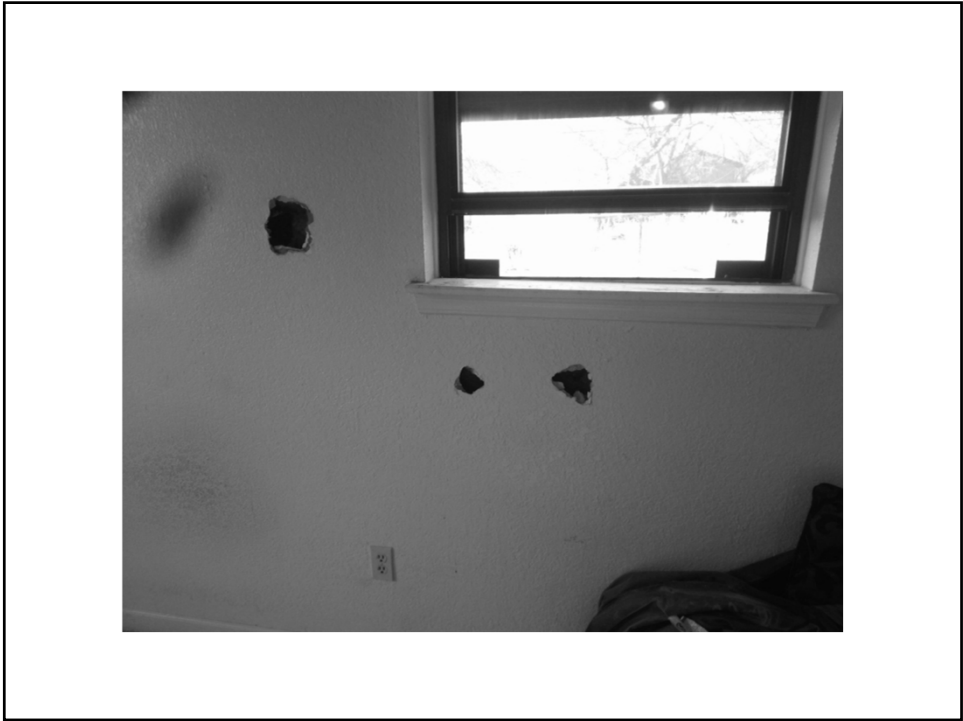
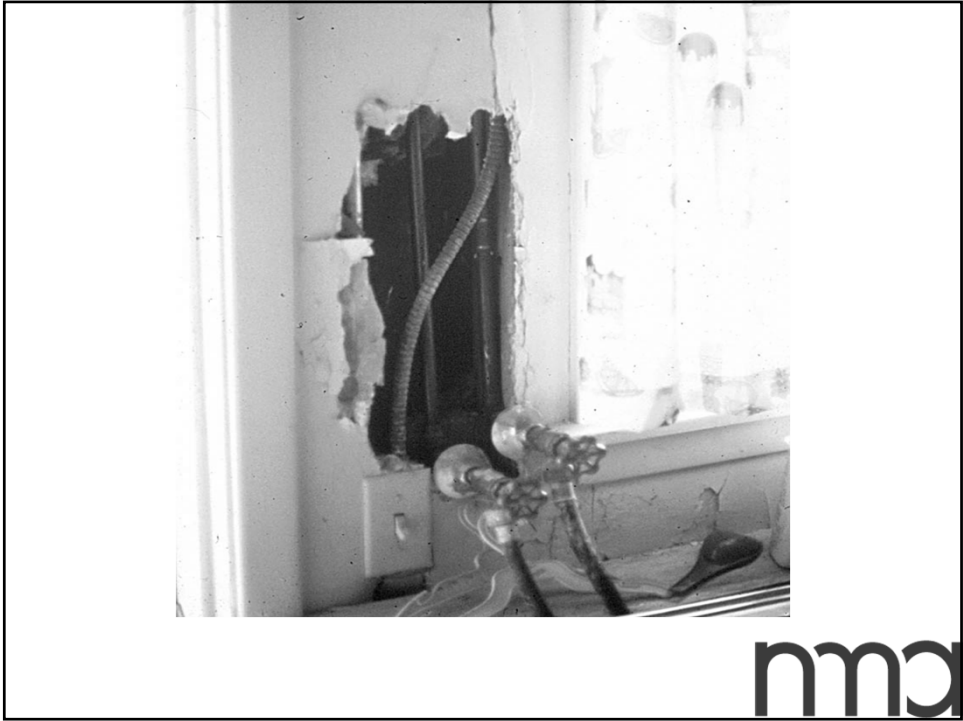
Deficiency 3: Interior wall has a hole that is greater than 2 inches in diameter or there is an accumulation of holes that are cumulatively greater than 6 inches by 6 inches.	
Deficiency Criteria:	
Unit & Inside:	A hole is greater than 2 inches in diameter. OR An accumulation of holes in any one wall that are cumulatively greater than 6 inches by 6 inches.
H&S Determination:	
Unit & Inside:	Moderate / Fail
Correction Timeframe:	
Unit & Inside:	30 days
More Information:	
Unit & Inside:	• None

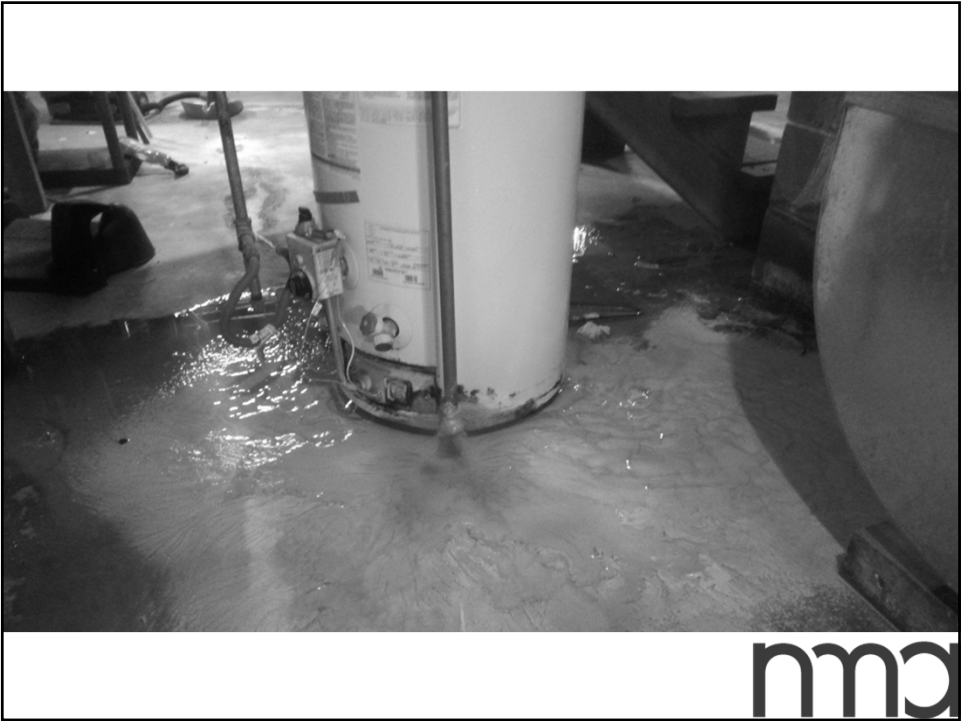
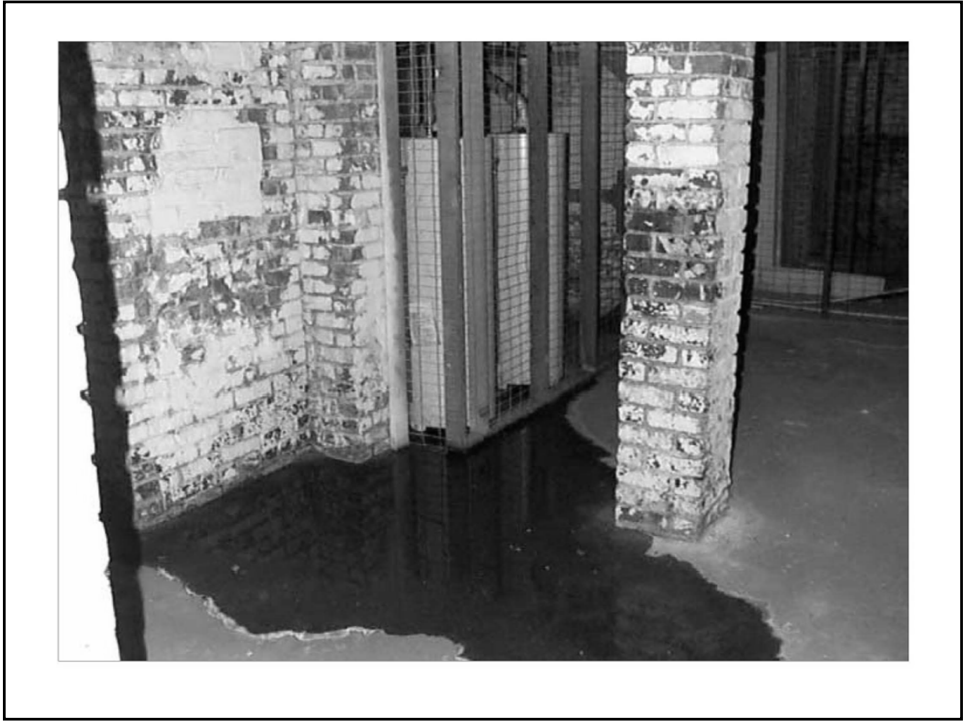
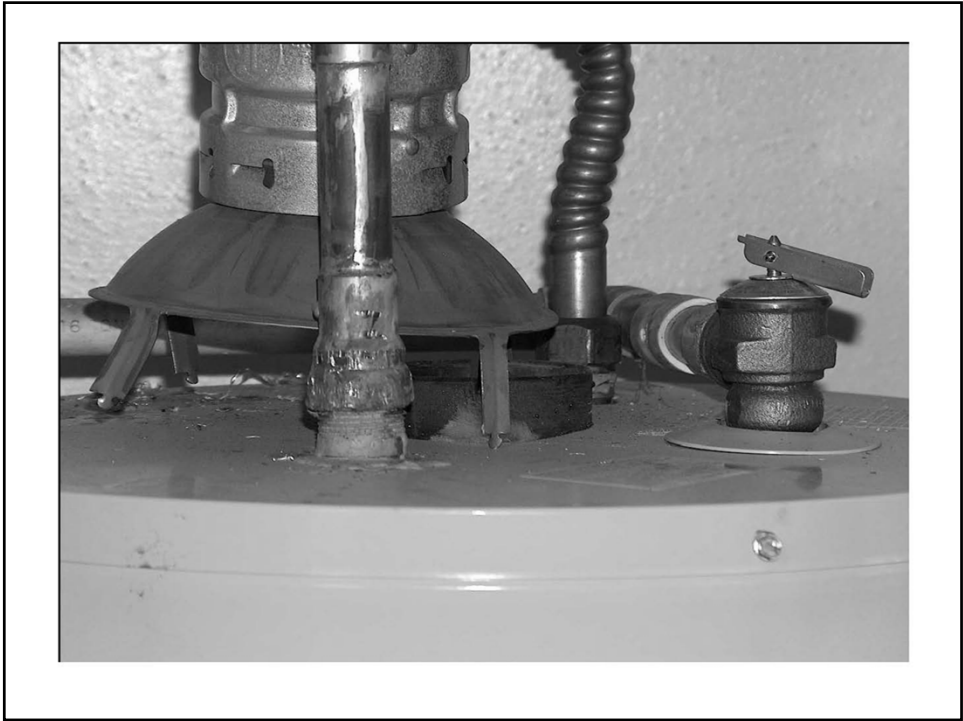
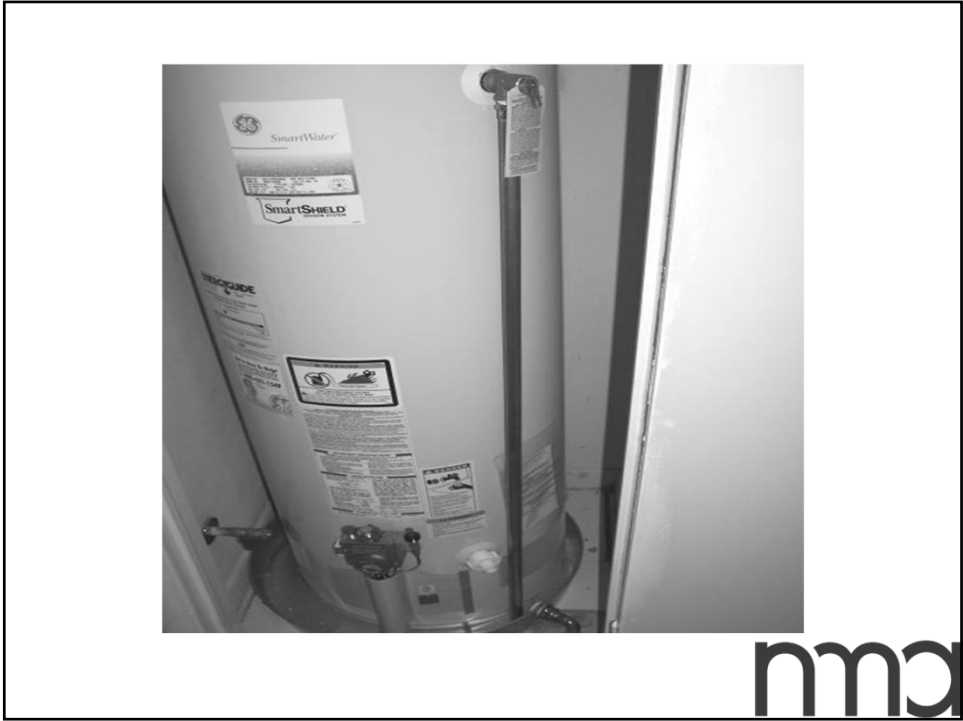
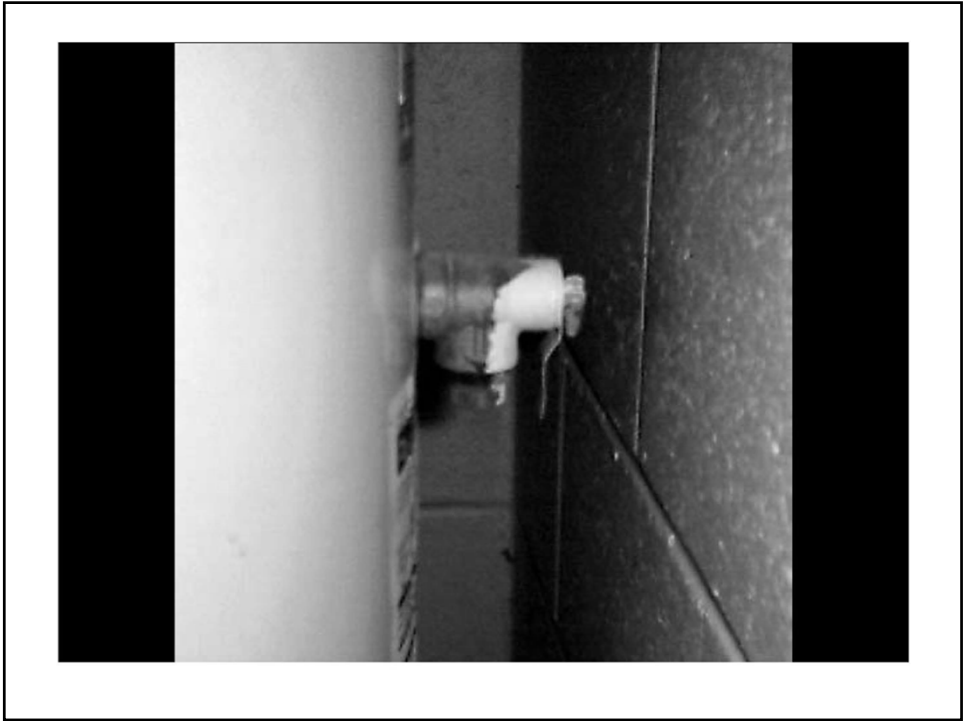
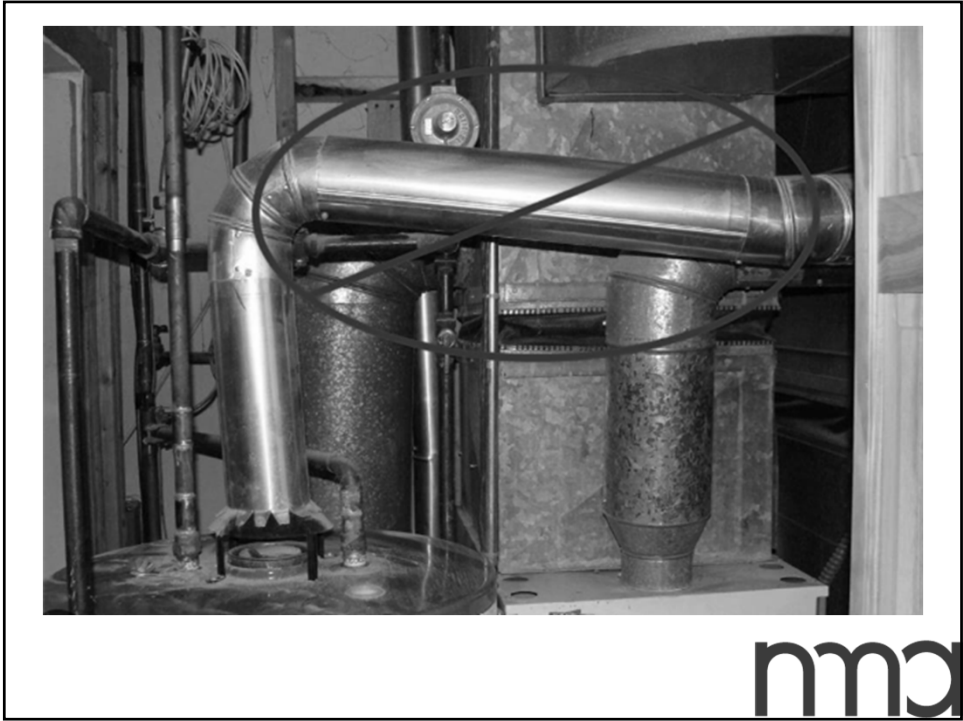
TPR valve has an active leak or is obstructed or relief valve discharge piping is damaged, capped, has an upward slope, or is constructed of unsuitable material.

Unit, Inside, & Outside:	TPR valve has an active leak. OR TPR valve is obstructed such that the TPR valve is unable to be fully actuated. OR Relief valve discharge piping is damaged (i.e., visibly defective; impacts functionality), capped, has an upward slope, or is constructed of unsuitable material.
--------------------------	---

Deficiency 3: The relief valve discharge piping is missing or terminates greater than 6 inches or less than 2 inches from waste receptor flood-level.	
Deficiency Criteria:	
Unit, Inside, & Outside:	The relief valve discharge piping is missing (i.e., evidence of prior installation, but is now not present or is incomplete). OR The relief valve discharge piping terminates greater than 6 inches or less than 2 inches from waste receptor flood-level.
H&S Determination:	
Unit, Inside, & Outside:	Moderate / Fail
Correction Timeframe:	
Unit, Inside, & Outside:	30 days
More Information:	
Unit, Inside, & Outside:	<ul style="list-style-type: none">If the relief valve discharge piping is plumbed through the wall and the inspector is unable to visually identify the termination point, then do not record as a deficiency.

Deficiency 4: Chimney or flue piping is blocked, misaligned, or missing.	
Deficiency Criteria:	
Unit, Inside, & Outside:	Chimney or flue piping is blocked, misaligned, or missing (i.e., evidence of prior installation, but now not present or is incomplete).
H&S Determination:	
Unit, Inside, & Outside:	Life-Threatening / Fail
Correction Timeframe:	
Unit, Inside, & Outside:	24 hours
More Information:	
	<ul style="list-style-type: none">Metal tape is not a substitute for substandard flue vent connections.

Unit, Inside, & Outside:	Gas shutoff valve is damaged (i.e., visibly defective; impacts functionality). OR Gas shutoff valve is missing (i.e., evidence of prior installation, but is now not present or is incomplete). OR Gas shutoff valve is not installed (i.e., never installed, but should have been).
--------------------------	--

More Information:	
Unit, Inside, & Outside:	<div>Acceptable relief valve discharge piping materials include:</div> <ul style="list-style-type: none">• Chlorinated polyvinyl chloride (CPVC) plastic pipe/tubing• Copper pipe• Cross-linked polyethylene (PEX) plastic tubing• Cross-linked polyethylene (PEX) plastic tubing• Ductile iron• Cross-linked polyethylene/aluminum/high-density• Polyethylene (PEX-AL-HDPE) pipe• Polyethylene (PEX-AL-PEX) pipe• Galvanized steel pipe• Polyethylene/aluminum/ polyethylene (PE-AL-PE) pipe• Polypropylene (PP) plastic pipe or tubing• Stainless steel pipe (type 304 or 316)
